**REPORT OF THE MARINE BOARD OF INVESTIGATION  
INTO THE  
COMMERCIAL FISHING VESSEL SCANDIES ROSE  
(O.N. 602351)  
SINKING AND LOSS OF THE VESSEL WITH FIVE  
CREWMEMBERS MISSING AND PRESUMED  
DECEASED SOUTH OF SUTWIK ISLAND, ALASKA  
ON DECEMBER 31, 2019**

**THE SINKING AND LOSS OF THE COMMERCIAL FISHING VESSEL SCANDIES  
ROSE (O.N. 602351) SOUTH OF SUTWIK ISLAND, ALASKA RESULTING IN  
THE LOSS OF FIVE LIVES ON DECEMBER 31, 2019**

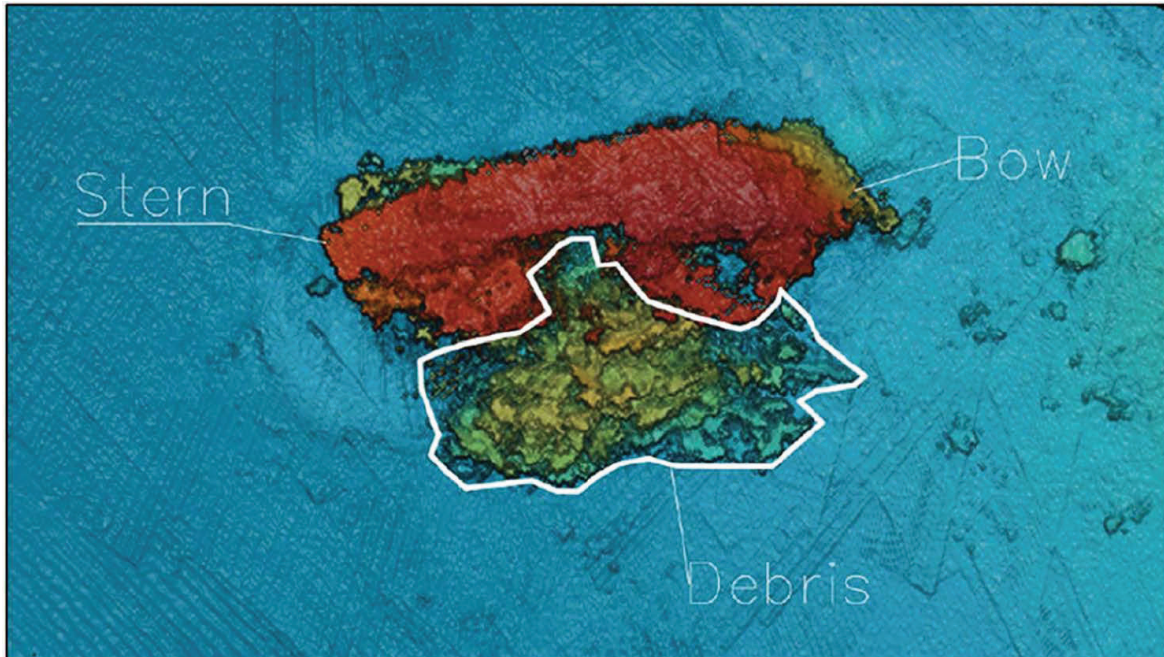
Figure 24 – Multibeam bathymetric surface image of the SCANDIES ROSE lying on its starboard side in an east-west direction with the bow pointing east. Off the deck side of the vessel is a debris field roughly 94 ft x 42 ft with height off the seafloor of approximately 20ft. (Source CG Exhibit 008, F/V SCANDIES ROSE Search and Survey Report, pg. 13)

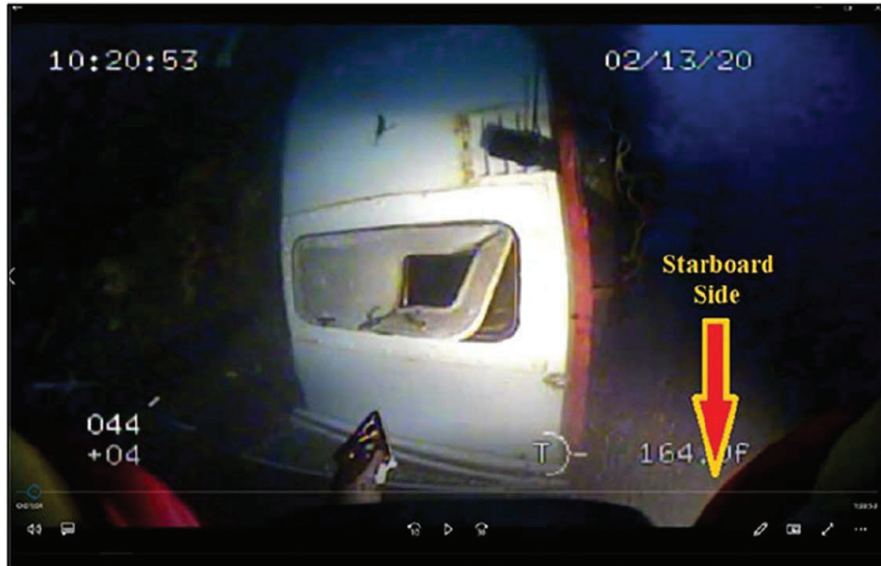
Figure 25 – After starboard side accommodation door of the SCANDIES ROSE on the after bulkhead showing damage. (CG Exhibit 008, with markup)

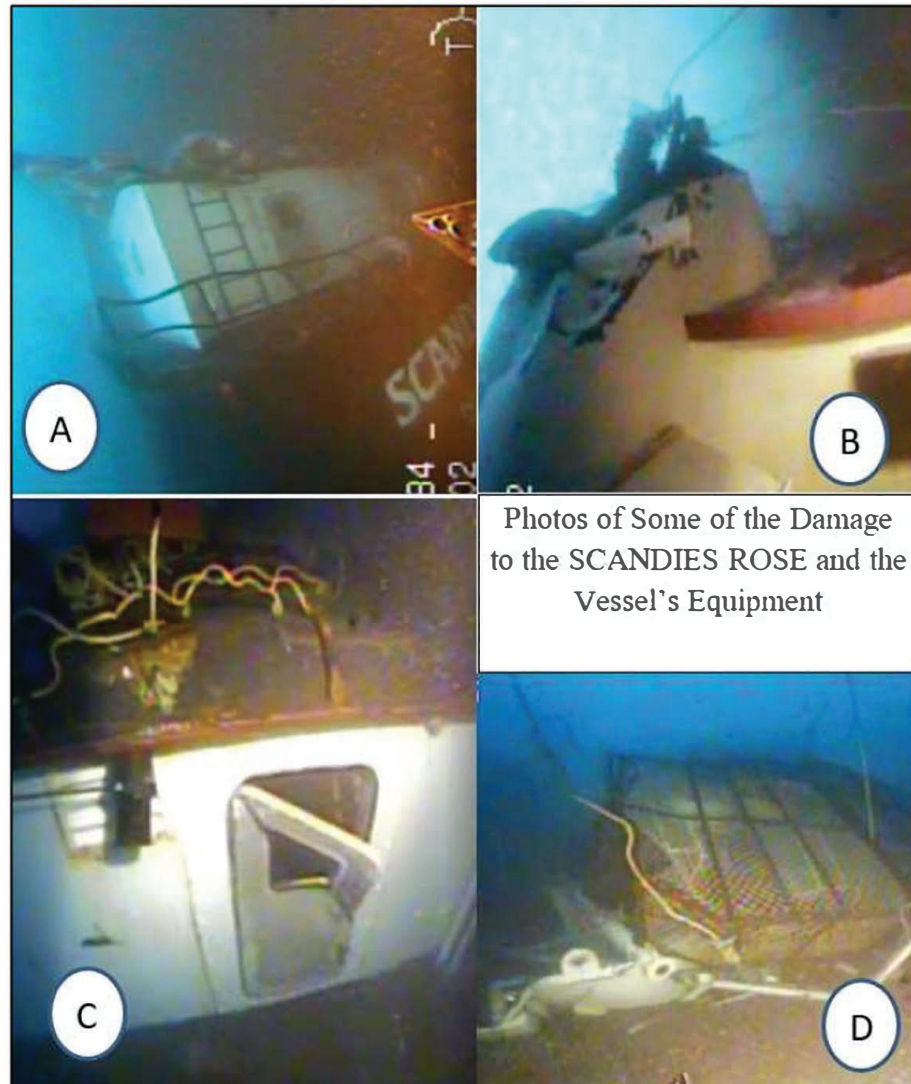
*Figure 26 – Images of the damage sustained to the SCANDIES ROSE and her equipment as the vessel settled on the seabed. Image “A” shows the damage to the railings that run across the stern of the vessel. “B” indicates the damage to the top of the exhaust stack while “C” shows the damage to an external door aft from the superstructure. Finally, image “D” shows the mast and one of the large crab traps on the sea floor near the SCANDIES ROSE. (Source CG Exhibit 009 still frames, with markup)*

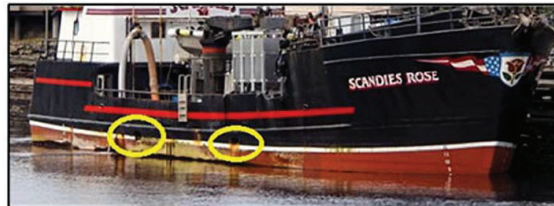
Figure 33 - Starboard side of the SCANDIES ROSE prior to the repair of the overboard chutes, taken several years earlier. Yellow circles indicate two chutes, one forward and one aft through the side shell plating and into the starboard pipe alley. (Source Mr. [REDACTED] ©, with permission and with Coast Guard mark up)

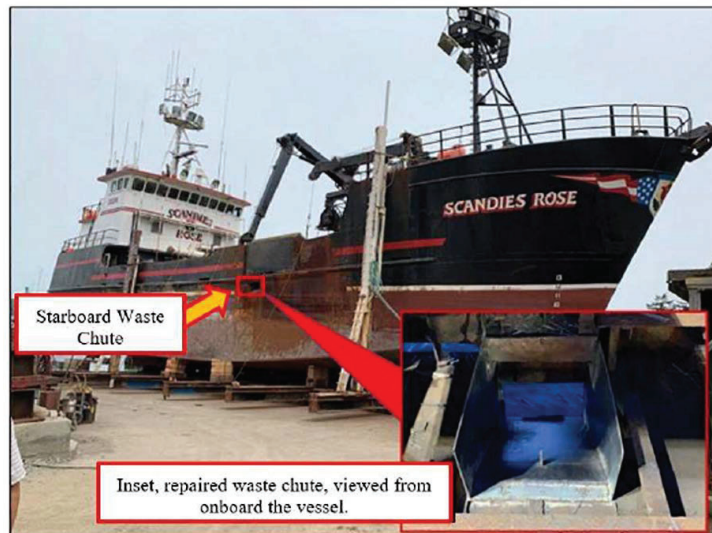
Figure 34 – SCANDIES ROSE on the blocks May 2019 at Lovric’s Shipyard, Anacortes, WA. “Starboard Waste Chute” highlighted, inset photo, lower right, displays the completely rebuilt starboard waste chute as repaired later in 2019 by High Mark Marine certified welders. (Source [REDACTED], with Coast Guard mark up)

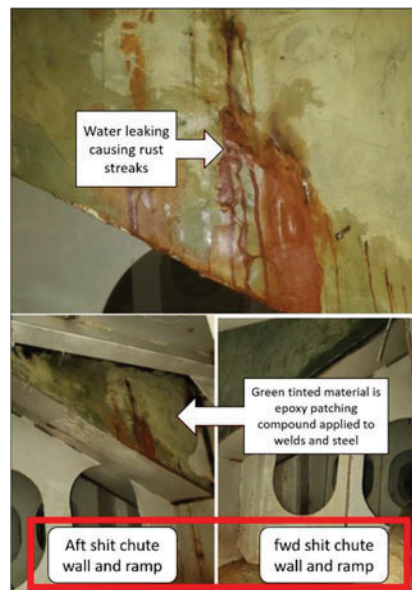
Figure 36 – Composite of the photos the SCANDIES ROSE Captain sent ashore showing the size and extent of the leakage and the areas where temporary repairs were made with a product called, “Splash Zone”®. Comments within the red box are vessel Captain’s comments, boxes with arrows are Coast Guard mark ups (Source CG Exhibit 112, with mark ups)

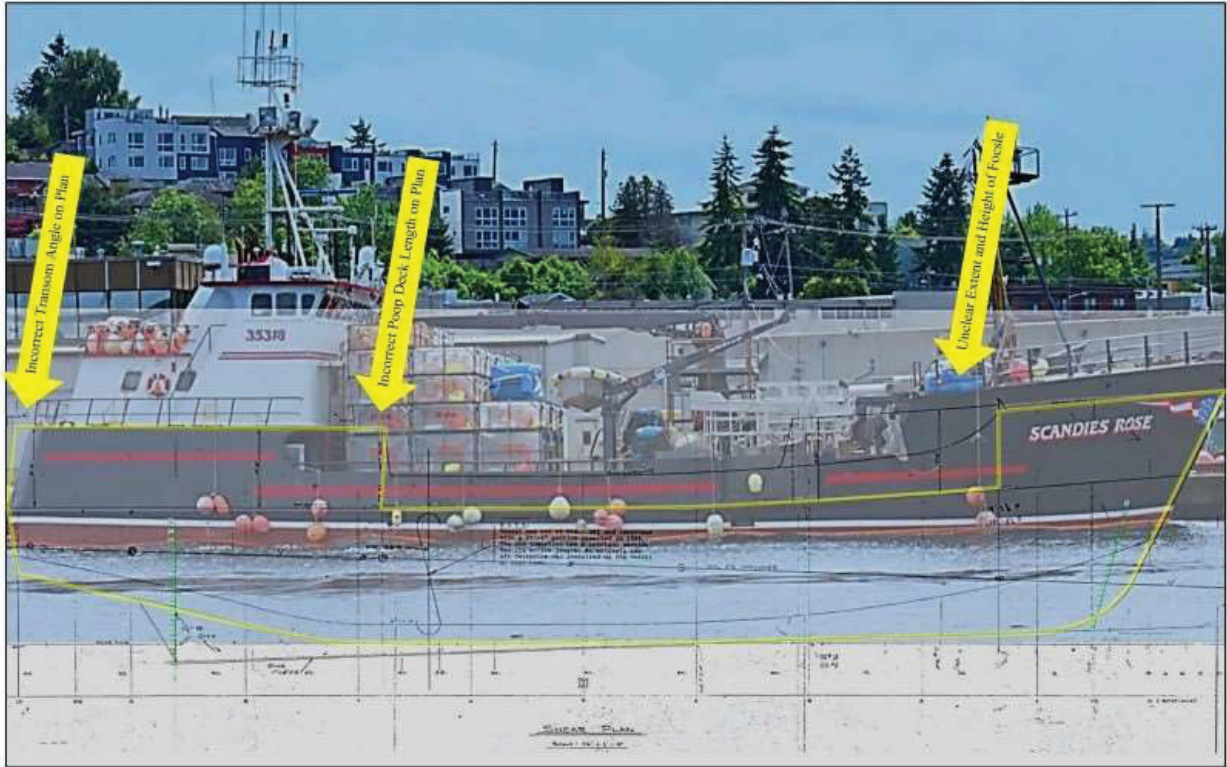
Figure 50 - Profile photograph of SCANDIES ROSE with Line Plans overlaid with watertight envelope highlighted in yellow and large profile differences in poop and forecastle called out. (Source; Coast Guard MSC Report, CG Exhibit 059)

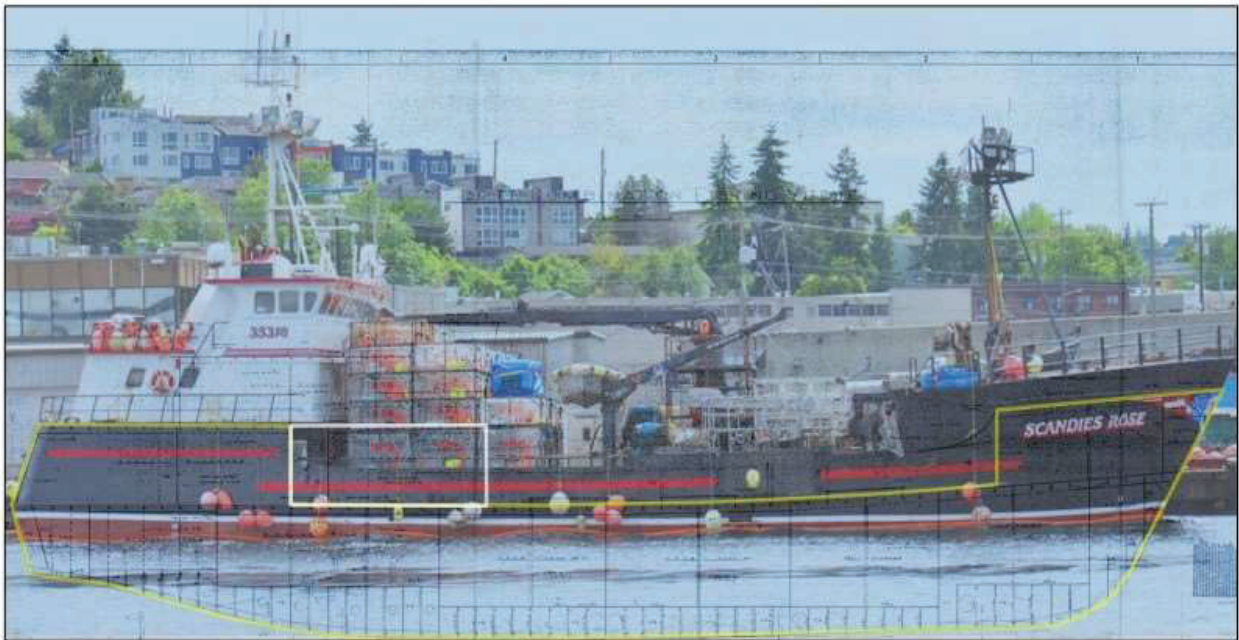
Figure 51 - Profile photograph of the SCANDIES ROSE with Scantling Plan and Profile overlaid. Note that the plan matches the vessel's transom but indicates additional buoyant volume at the forward end of the poop. (White highlighted area) (Source USCGR MSC Report, CG Exhibit 059)

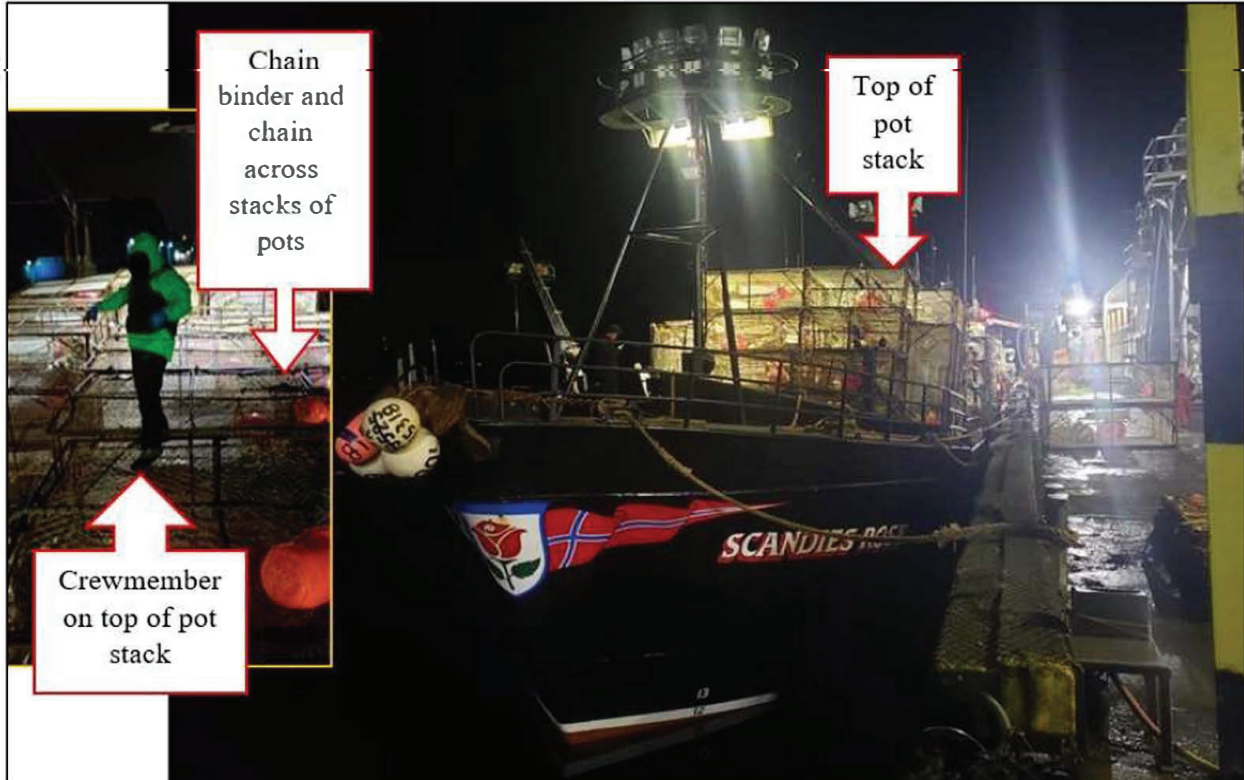
Figure 58 – SCANDIES ROSE at the dock just prior to departure with chain binders, chains and height of the pot stack at its highest point shown. (Source Mr. [REDACTED] and Mr. [REDACTED])

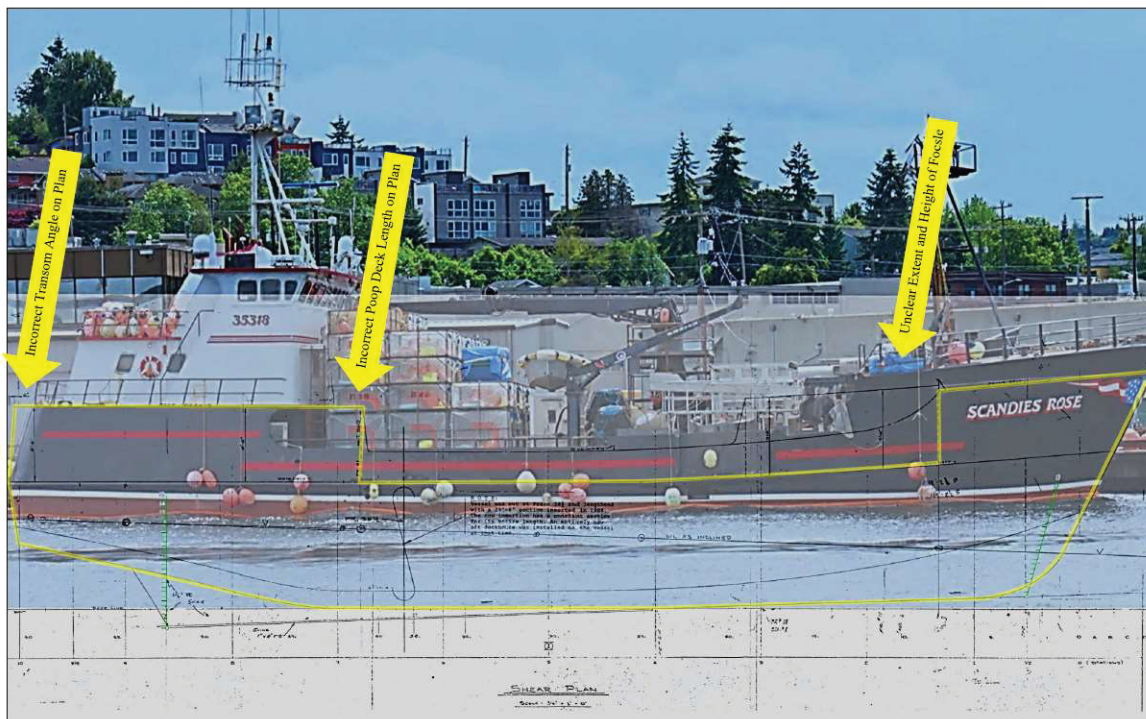
Figure 81 – 2019 Profile photograph of SCANDIES ROSE with Lines Plan profile overlaid with watertight envelope highlighted in yellow and large profile differences in the poop and forecastle called out. (CG Exhibit 059, Pg. 9)

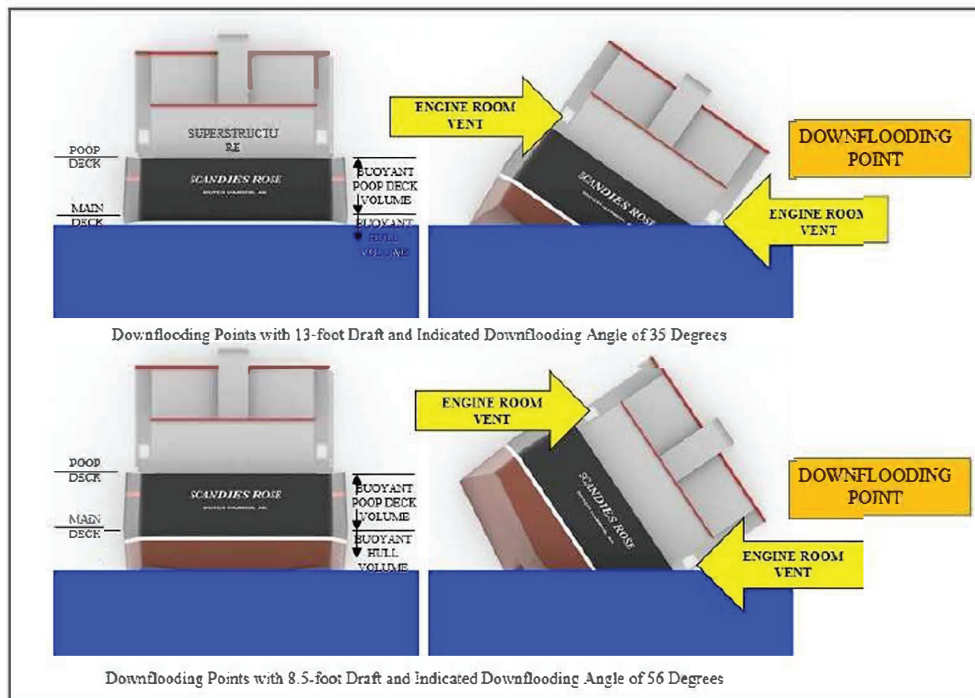
Figure 85 – Identifications of the SCANDIES ROSE for various drafts of 13.5 ft and 8.5 ft showing the effect on where the water might enter the air intakes for the engine room which the MSC identified as the “downflooding point.” The Naval Architect that conducted the 2019 stability assessment discounted these flooding points without examining them as a potential point for flooding. He did not physically look at these intakes and assumed later when the SCANDIES ROSE sank that they led to the centerline of the vessel and would have negligible effect on potential downflooding. (Source Coast Guard)

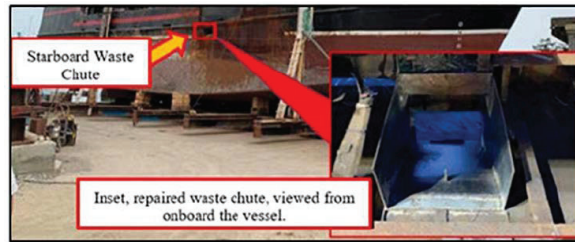
Figure 94 – SCANDIES ROSE on the blocks May 2019 at Lovric's Shipyard, Anacortes, WA. "Starboard waste chute" highlighted, with inset photo showing repaired waste chute as viewed from onboard the vessel, looking outboard. Inset photo, lower right, displays the completely rebuilt starboard waste chute as repaired later in 2019 by High Mark Marine certified welders in Kodiak, AK. (Source [redacted])
