MIR-22/26

# Capsizing of Liftboat *SEACOR Power*

Port Fourchon, Louisiana

April 13, 2021

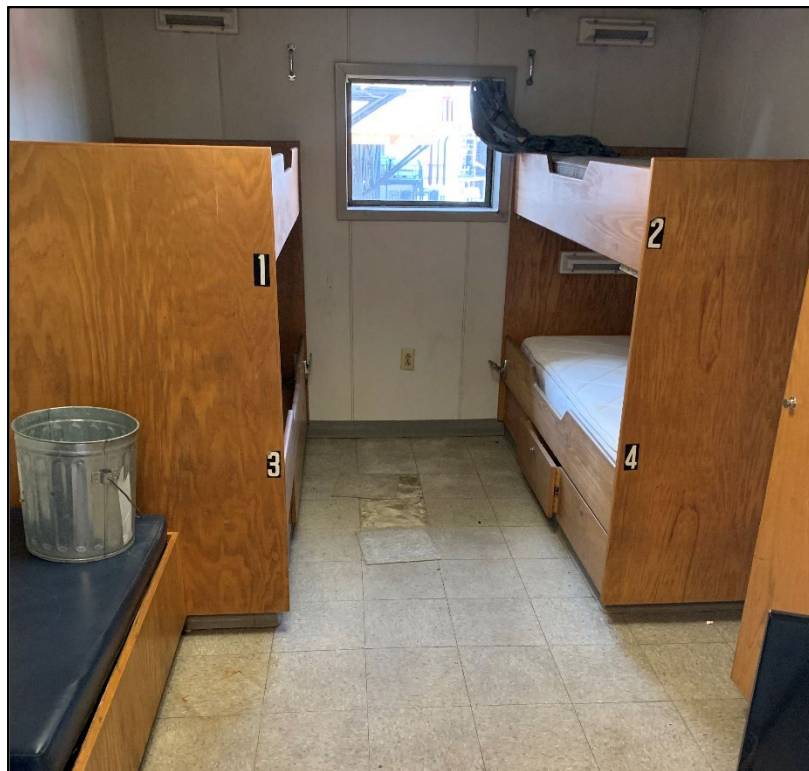
OWs 1 and 2 were asleep when the vessel capsized. Lockers on the port side of the room came loose from the bulkhead and fell inboard, blocking the inward-swinging door to the passageway. OW 2 was able to push ceiling tiles aside and egress the room via the crawl space in the overhead and into the [athwartship](#) passageway, now a vertical shaft, where he saw water already halfway up the space.<sup>4</sup> OW 1 was unable to egress through the crawl space, so he donned a lifejacket, broke the window in the aft bulkhead of the room with an extinguisher while standing on the side of the bed, and exited (see Figure 5).

**Figure 5.** Stateroom with window on aft bulkhead, similar to the one OW 1 and 2 were in, aboard the *SEACOR Legacy* (a similar vessel). Note this vessel was not in service and outside equipment was stowed in rooms during an NTSB visit.

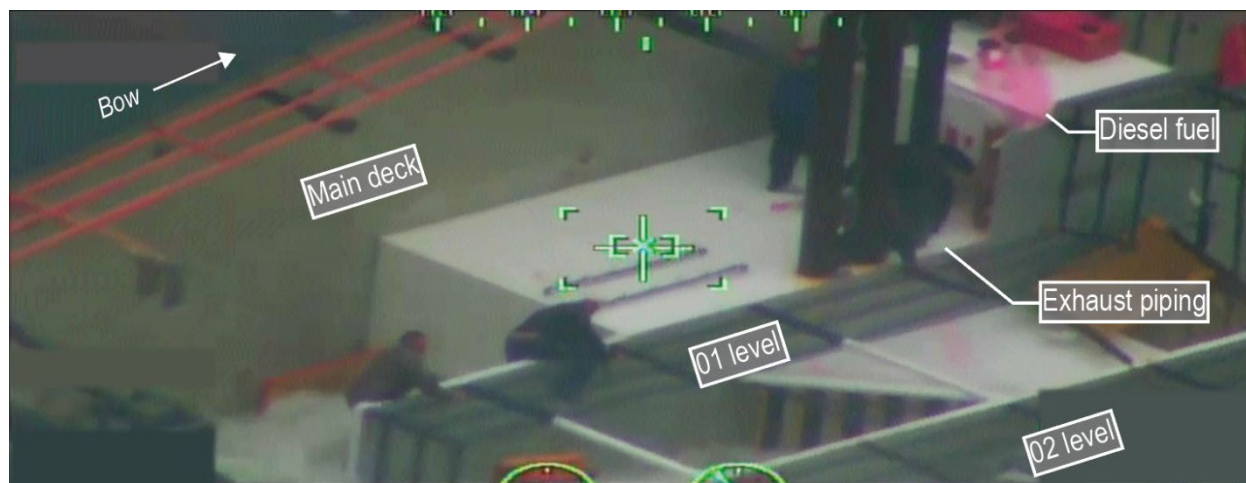
Six personnel were gathered on the port side of the *SEACOR Power*: OWs 1, 2, and 3; ABs 1 and 2; and the night cook. They were “pummeled by waves and rain,” according to one of the survivors (see Figure 6). Four of six (OW 2, the night cook, and the two ABs) did not have lifejackets. Diesel poured from tank vents, making the structure and survivors slippery, and a loose wooden bench injured OW 1’s foot. OW 2 saw the well site supervisor float by in a lifejacket but was unable to reach him. OW 1 was next swept away by the seas and drifted away from the vessel.

**Figure 6.** Port side of the capsized hull as seen from *Glen Harris* about 1755. Some personnel are visible. (Source: *Glen Harris*)

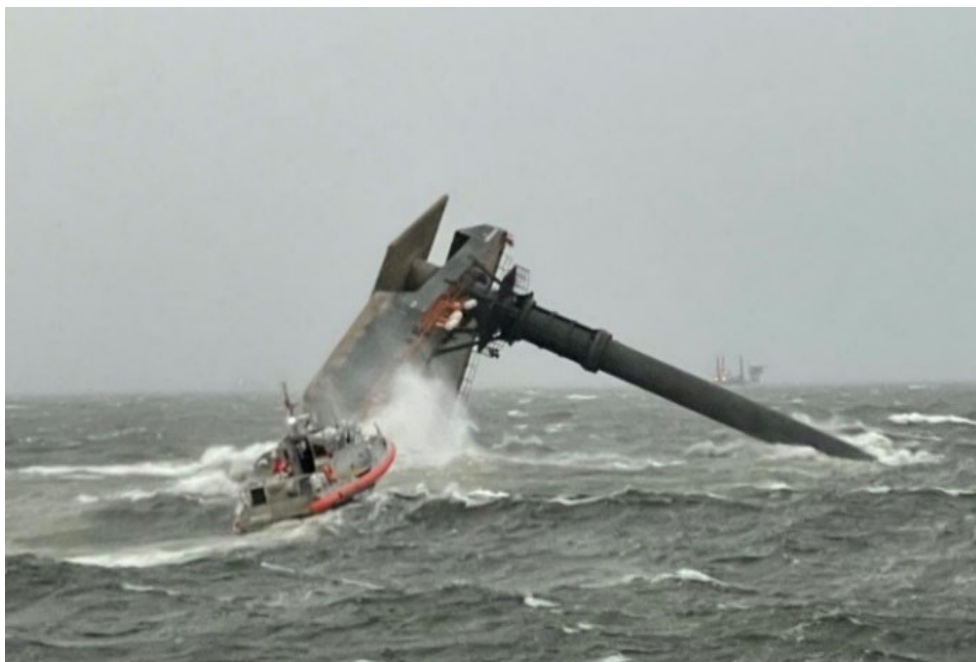
**Figure 8.** *SEACOR Power* capsized on its starboard side on the evening of the casualty, with a Coast Guard RB-M in the foreground and the liftboat *Rockfish* in the background. (Source: Coast Guard)

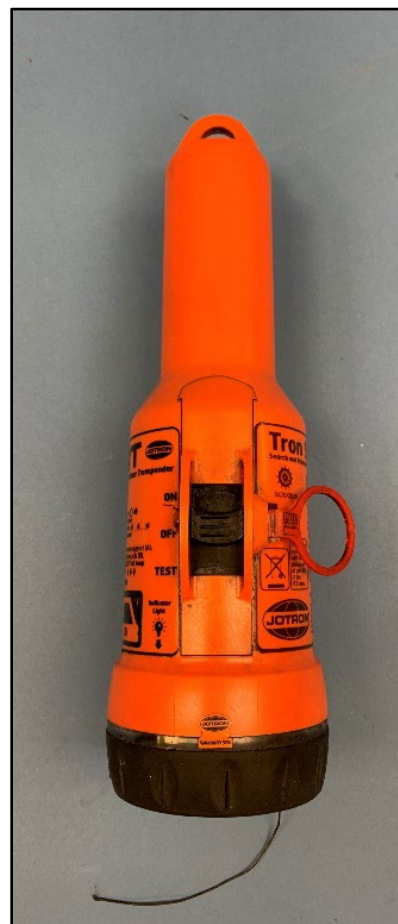
Figure 14. *SEACOR Power* SART following the casualty.

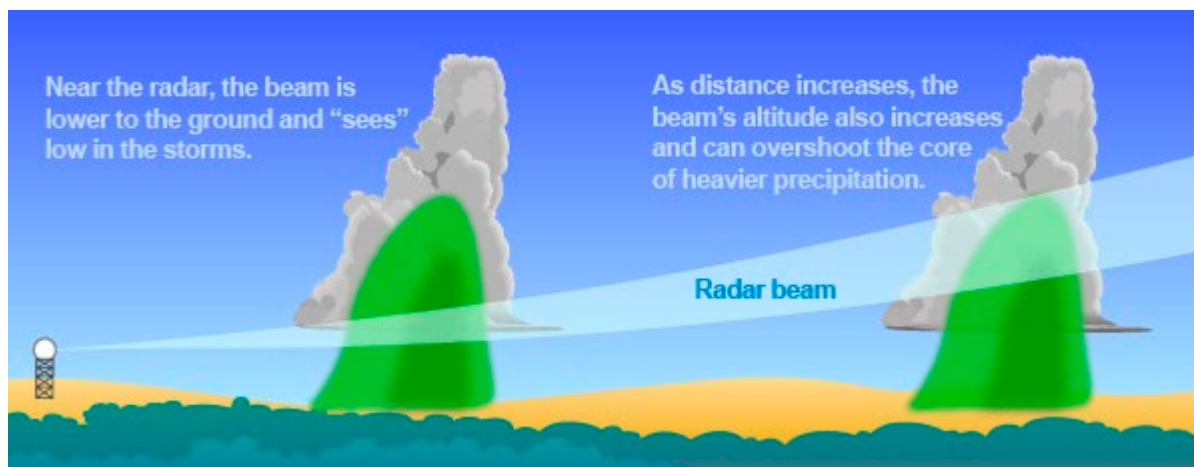
KLIX was about 82 miles north-northeast of the capsizing site at an elevation about 80 feet above mean sea level (msl). At this distance, the  $0.525^\circ$  upward tilt of the KLIX radar would have “seen” altitudes above the capsizing location about 5,100 to 13,300 feet above msl (see Figure 17).<sup>20</sup>

**Figure 17.** At increasing distance, the radar is viewing higher and higher in storms, and the beam may overshoot the most intense parts. (Source: NWS)

Because the localized weather could not be detected by nearby radars due to their elevation angles (antenna angles relative to the horizon), we recommended that the National Weather Service, Federal Aviation Administration, and Air Force work together to assess coastal weather radar sites to determine if it is safe and appropriate to lower the radar angles, and then lower the angles of the lowest radar beams where appropriate.

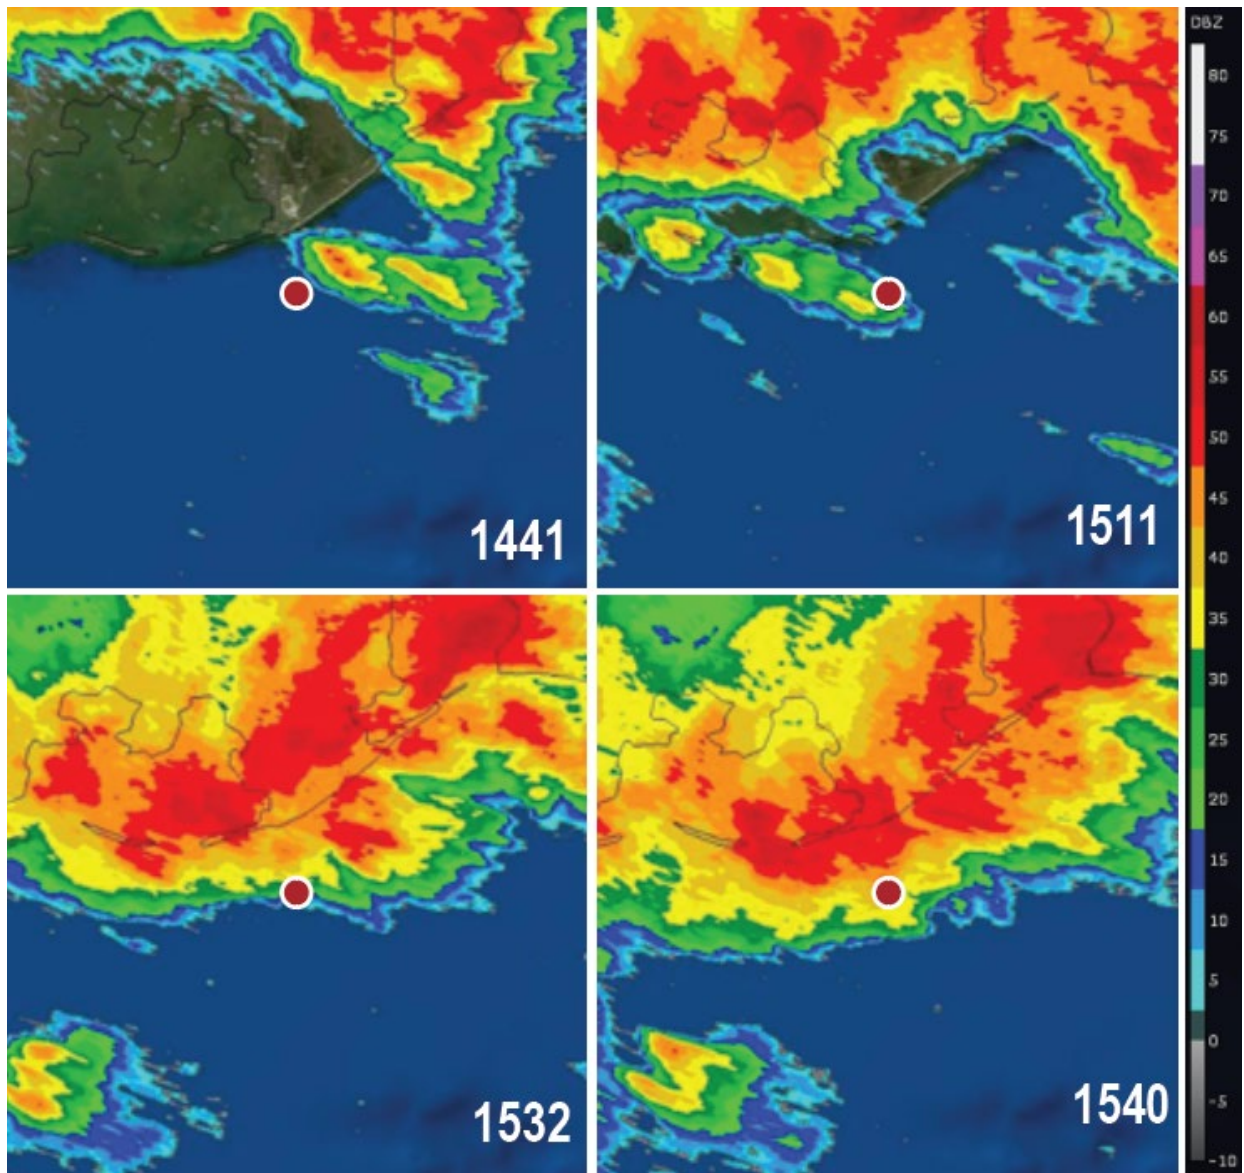
Figure 18 presents KLIX weather radar reflectivity imagery 1) about one hour before the casualty (about 1441), 2) 30 minutes before the casualty (about 1511), 3) as light reflectivity associated with the leading edge of the MCS initially moved over the vessel (about 1532), and 4) about the time of the casualty.

**Figure 18.** KLIX Level-II 0.525° base reflectivity images from sweeps initiated about 1441, 1511, 1532, and 1540. Casualty site is denoted by the red circle. The colors represent the strength of returned energy to the radar expressed in values of decibels (dBZ). The color scale is located to the right. Generally, as dBZ values increase so does the intensity of precipitation. (Source: NWS)

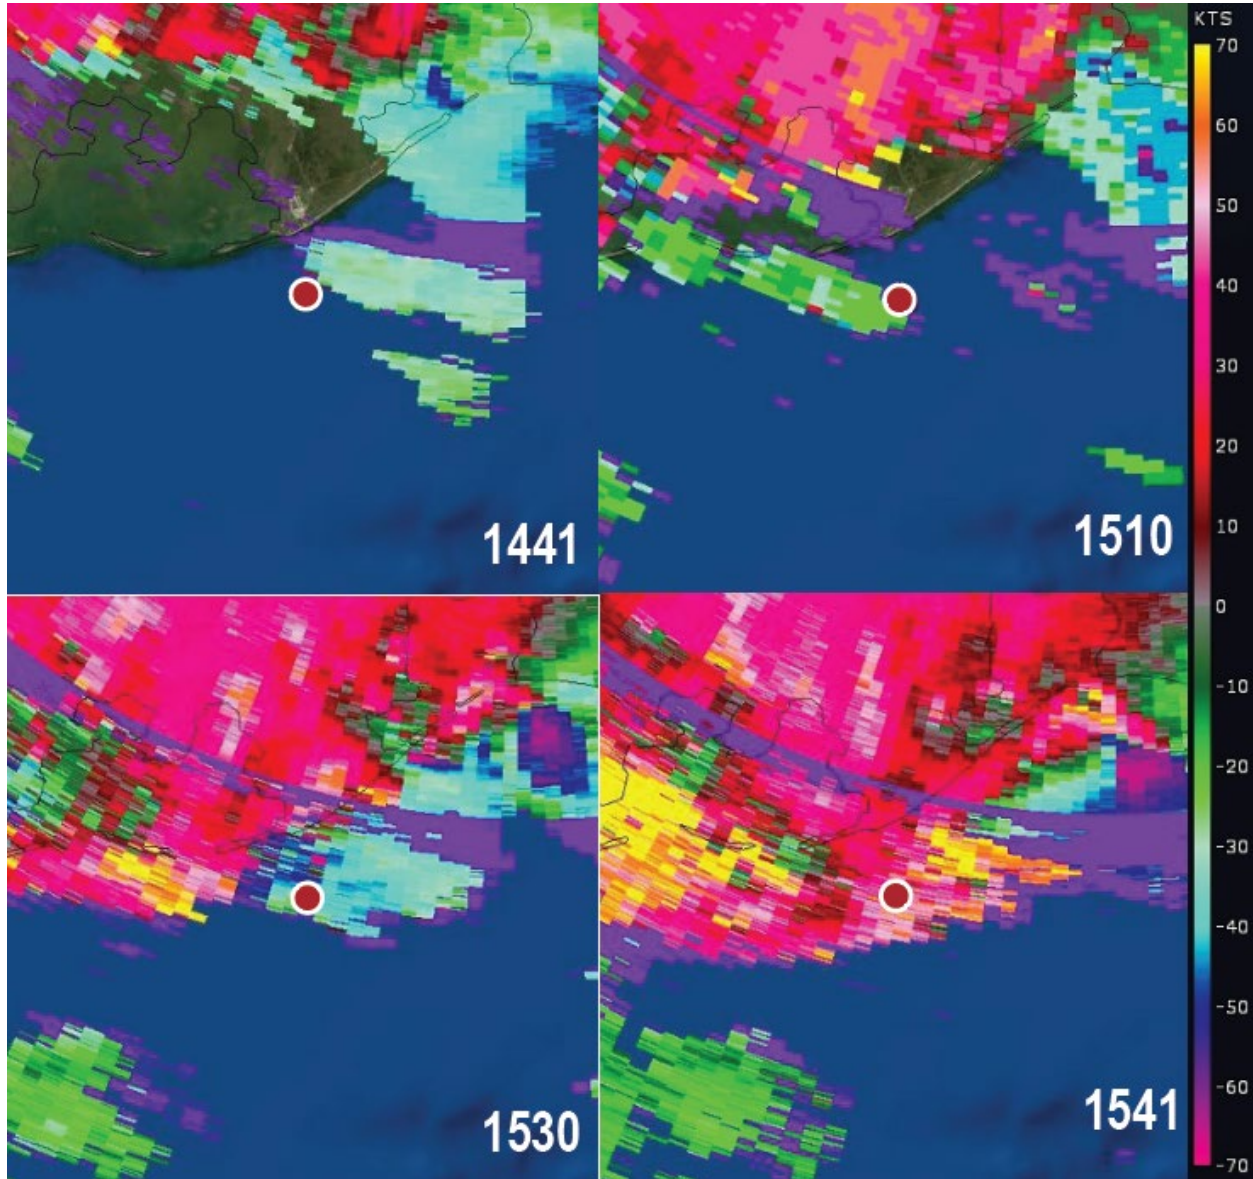
direction either directly toward the radar (negative values; more green/blue colors) or directly away from the radar (positive values; more red/yellow colors). As with the reflectivity data, KLIX's location and angle meant that the data "seen" at the capsizing location was about 5,100 to 13,300 feet above msl.

**Figure 19.** KLIX Level-II 0.525° base velocity images from sweeps initiated about 1441, 1510, 1530, and 1541. Casualty site is denoted by the red circle. The colors represent the calculated wind speed, in knots. (Source: NWS)

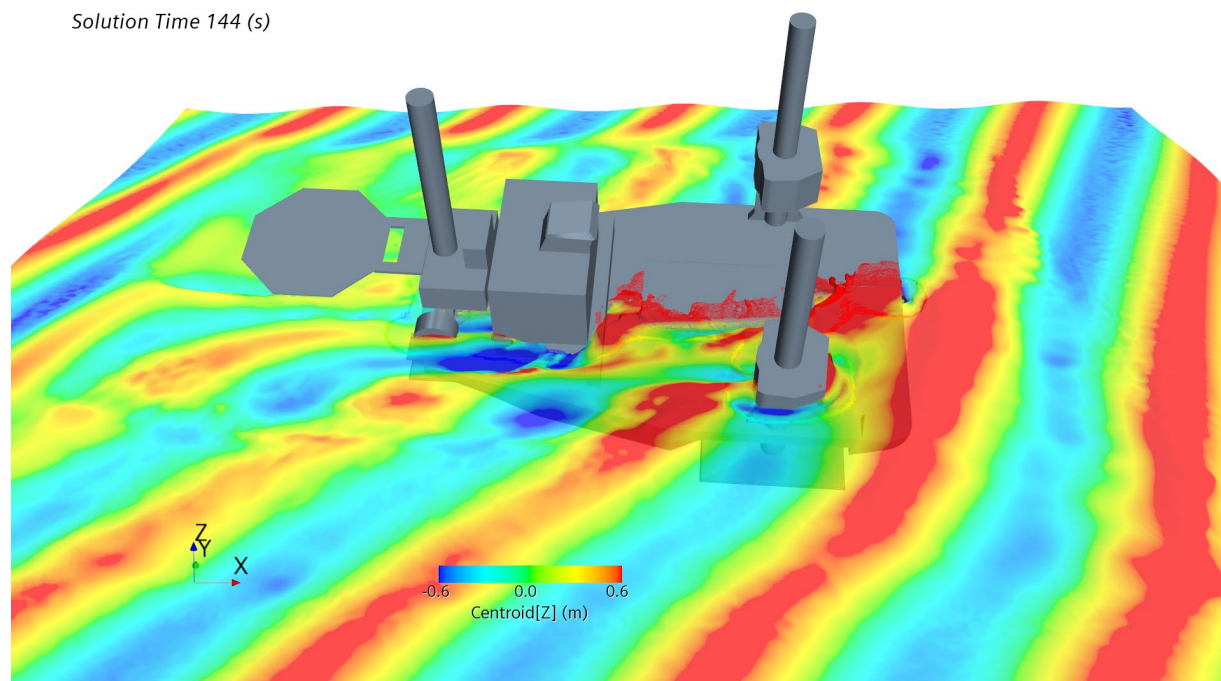
- Case 3 explored whether the model maintained stability with co-linear winds and waves from 285° and cross waves from 023°. This case was designed to simulate the effects of both swells and wind-generated waves on the *SEACOR Power* under tested wind conditions. The CFD analysis showed that the vessel capsized under these conditions.

**Figure 23.** Illustration of the CFD analysis for step 8, case 1, simulating the effect of wind gusts with swells. Colors indicate wave height, with blues in low areas and reds in high areas. The vessel capsized in the simulation.

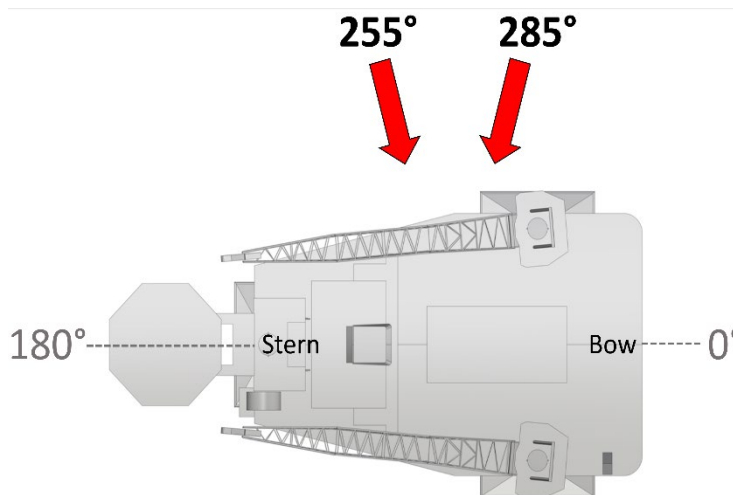
The *SEACOR Power* met stability criteria when subjected to the maximum wind thresholds in the regulations (70 knots) in calm seas, but actual winds during the capsizing were above the regulatory threshold, with gusts to 80 knots. The ABS CFD analysis found that, with the *SEACOR Power* in the casualty loading condition (9 feet 3 inches load line draft with 2.5 feet of trim by the stern; legs lowered 10 feet), the vessel was vulnerable to capsizing with winds off the beam and seas at 4 feet (see Figure 24). Although the storm initially hit the *SEACOR Power* from astern, the mate turned the liftboat to port in an attempt to put the bow into the wind and slow the vessel down to soft tag the bottom. This maneuver put the winds on the vessel's port beam. The CFD model of the vessel capsized in 80-knot winds when the wind direction was just forward of the port beam (285° relative) and swells of 4 feet were coming from off the starboard bow (023° relative). The CFD model of the vessel also capsized when these wind and swell conditions were combined with wind-generated waves moving in the same direction as the winds.

**Figure 24.** Most vulnerable wind direction axes for port side of the *SEACOR Power* as determined by CFD analysis.
