NATIONAL TRANSPORTATION SAFETY BOARD

Search and Rescue Transponder (SART)

Specialist's Factual Report
By Sean Payne

Location: Port Fourchon, LA
Date: April 13, 2021
Type: Liftboat
Registration: *SeacorPower*
Owner: Falcon Global Offshore, LLC.
Operator: Seacor Marine, LLC.
NTSB Number: DCA21MM024

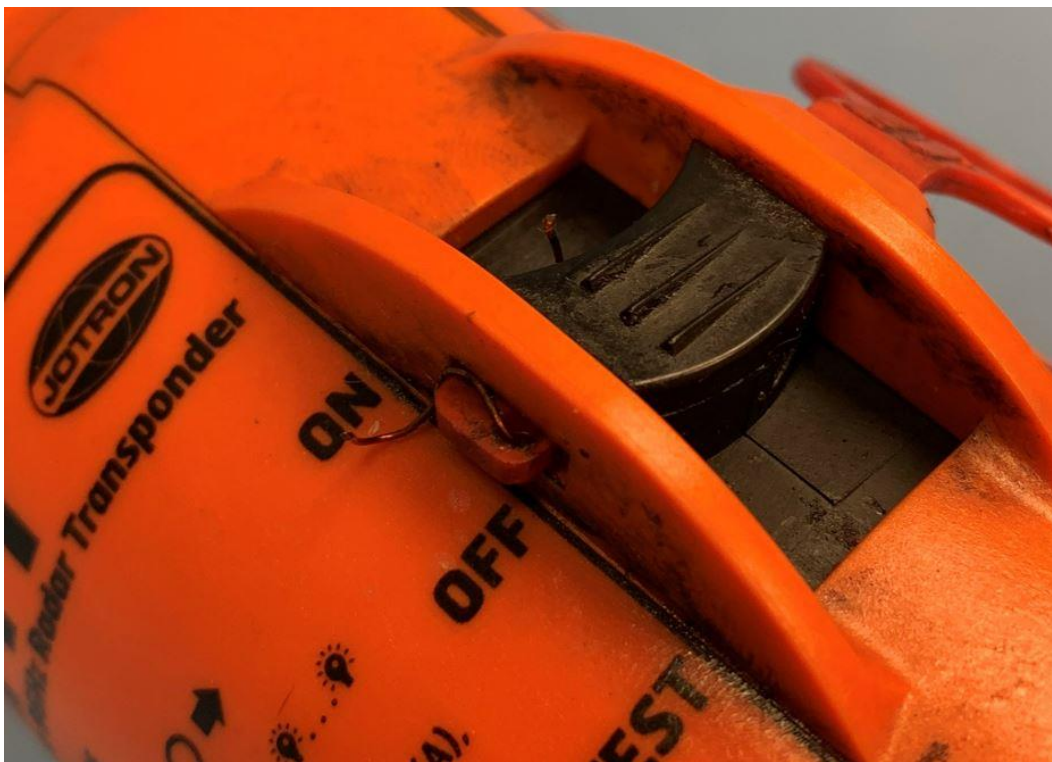
The device's activation pin was examined. The device activation pin's safety wire was broken (figure 2), indicating that the device had been activated at some time.

Figure 2. Broken safety wire (copper color) indicating the device had been activated at some time.

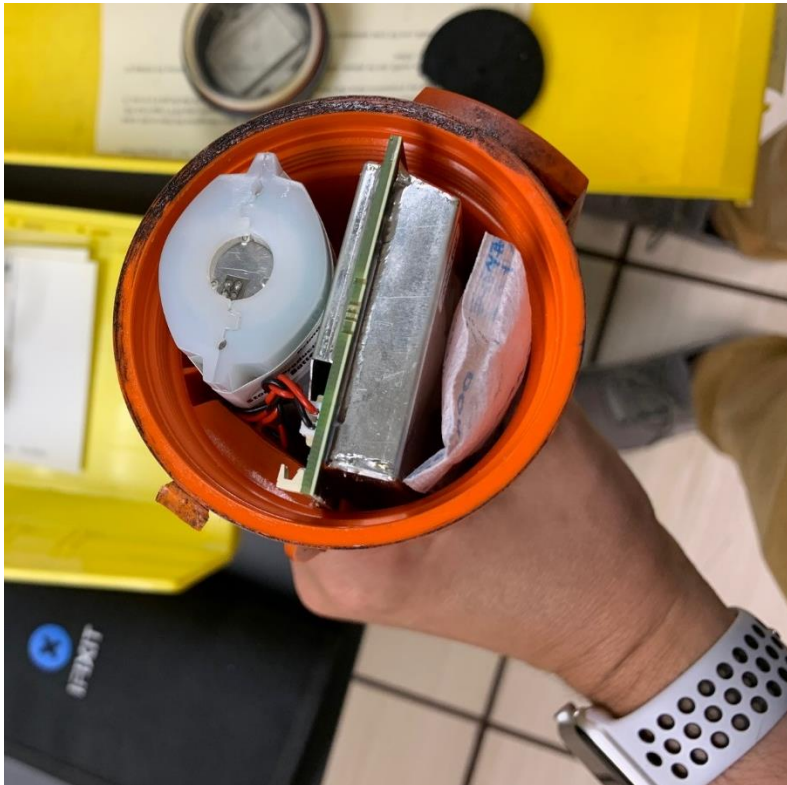
The device's component seal (sticker) affixed at the interface between the bottom lid and the housing was examined and was not broken. The device was then disassembled by unscrewing the bottom lid from the housing. During this process, it was noted that the component seal did not break and the seal slipped around the bottom lid as it was unscrewed. Figure 3 is a photograph of the device after the bottom lid had been removed. All internal components were as described. The desiccant packs were removed and found to be dry. The internal components were examined and found to be dry with no evidence of water intrusion, or corrosion.

Figure 3. Internal component view during inspection.

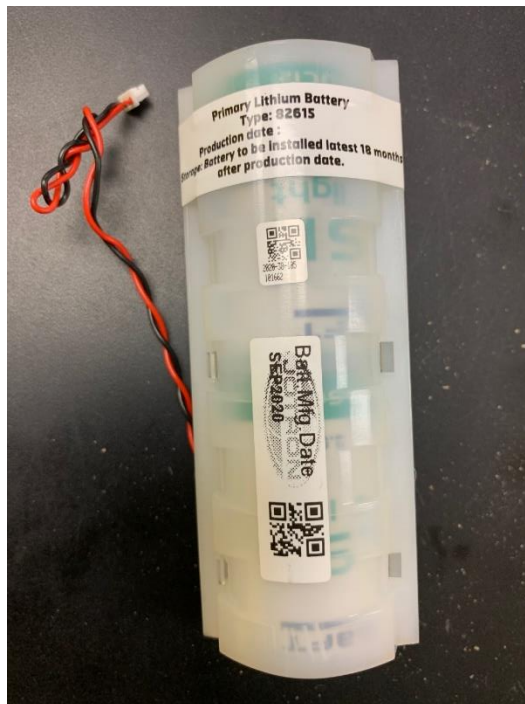
The device's battery was then unplugged and inspected. The battery and battery label are pictured in figure 4. The battery had a manufacture date of September 2020. The battery was tested with a voltmeter and was found to be holding 7.3 volts. This is consistent with a near full battery charge according to the manufacturer's specifications.

Figure 4. The battery after removal from the device.

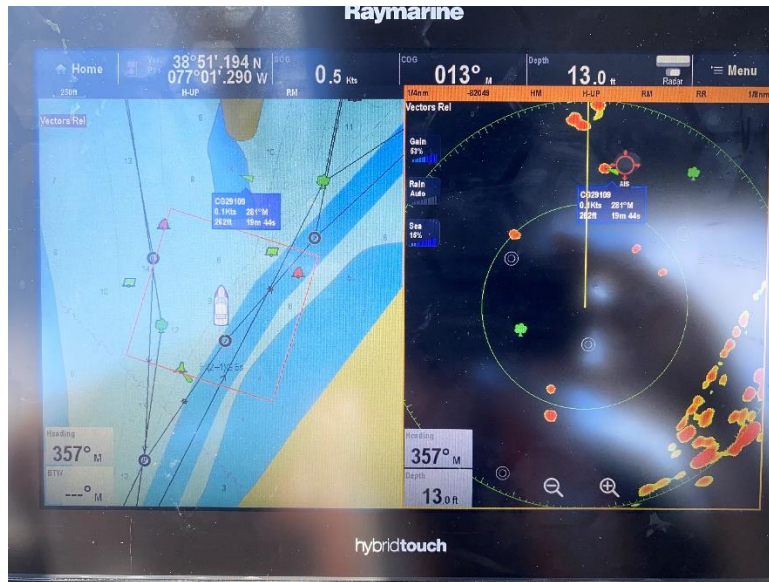
Upon activation a low volume tone from the SART was audible. The SART's red LED light flashed approximately twice per second. At test point 1 (range inside 0.5 nm), the SART was not observed by vessel RX or the *John Glenn*. The height and orientation of the SART was changed at test point 1. The SART was activated at various heights, including mounted to a bosun's pole approximately 9 feet above the water. The SART was held in these orientations for approximately 5 minutes. Figure 5 is a picture of the SINS-2 radar display on the USCG 29' Vessel RX. Figure 6 is a picture of the Garmin radar display on the *John Glenn*. Note that range in figure 5 was set to 1/8 nautical miles (NM) and the range in figure 6 was set to 2 NM.

Figure 5. Display from Vessel RX at range rings of 1/8 NM. The location of Vessel TX is shown on the radar display as target "CG29109".

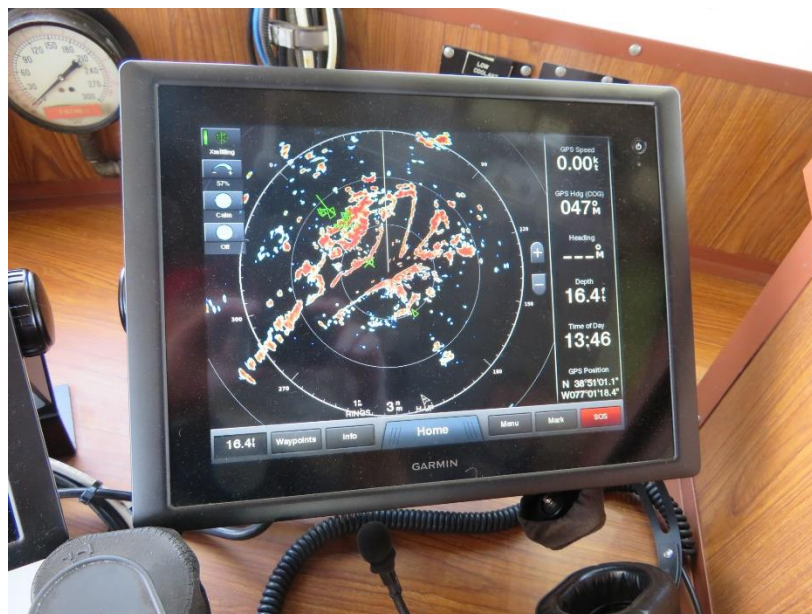
Figure 6. Display from the *John Glenn* at range rings of 2 NM.

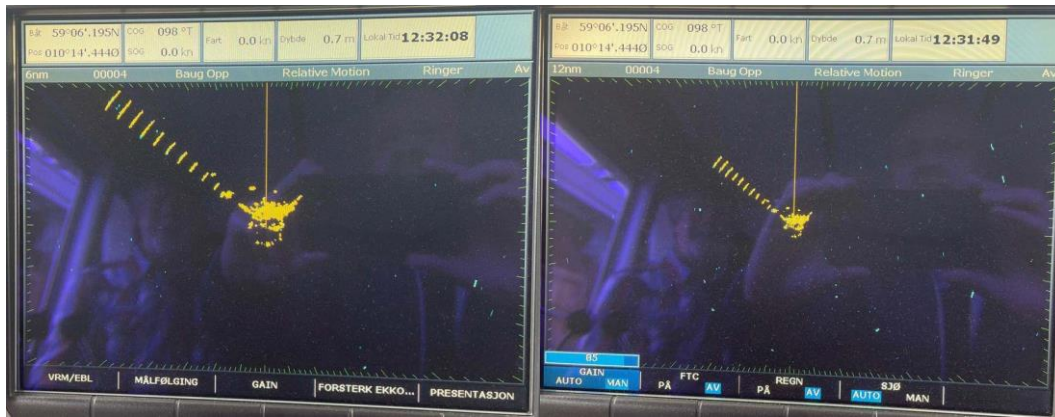
The manufacturer then conducted the OTW portion of testing in Sandefjordsfjorden. The OTW testing consisted of operating the beacon at two different land locations with a stationary X-band radar system at a third, stationary location. In "position A" the SART was placed approximately 1 NM from the stationary X-band system, and in "position B" the SART was placed approximately 0.4 NM from the X-band system. The stationary X-band system was a Raymarine E120 4kW X-band system. One NSIA representative and the representative from Seacor Marine was placed on the stationary X-band radar system, and another NSIA representative was placed with the beacon. In both positions the beacon was activated and the radar image response was documented at the stationary system. The height of the beacon at "position A" was approximately 1 meter above sea level and the height of the beacon at "position B" was approximately 3 meters above sea level. Figure 9 shows the radar's display at "Position A" and figure 10 shows the radar's display at "position B." Both displays showed the appropriate response at the given distance (a 12 striped converging cone at distances > 1 NM and a series of 12 concentric circles at a position < 0.4 NM).

Figure 9. The radar's display at "position A." Note one image shows the radar display's range rings set to 6 NM, and the other to 12 NM.

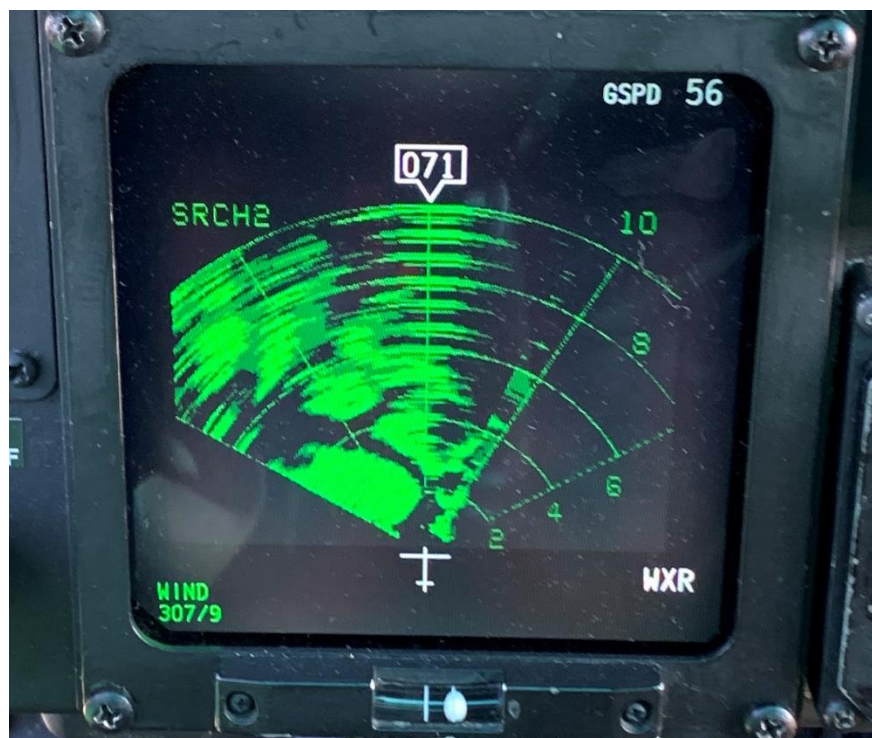
For safety reasons, the USCG aircrew was specifically briefed on the operation and best practices to detect the SART beacon. A set of specific test points were designed to maximize operational safety of the helicopter and the chance of a successful reception of the beacon. These cards were supplied to the USCG aircrew prior to the test and were briefed prior to the flight by NTSB personnel. The SART beacon was placed on a tripod approximately 3 m above sea level, with the antenna facing skyward. The USCG helicopter flew the test points as described on the test cards and was able to successfully receive the beacon. The test cards are attached to this report as Attachment 6. Figure 15 is a photo of the MH-65C's radar display showing a successful reception of the beacon. Note that the RDR-1300C radar system is forward looking, and is unable to display concentric rings displayed from an activated SART at close ranges.

Figure 15. A picture of the MH-65C's RDR-1300C radar display when receiving the SART.
