**REPORT OF THE MARINE BOARD OF INVESTIGATION  
INTO THE  
COMMERCIAL FISHING VESSEL SCANDIES ROSE  
(O.N. 602351)  
SINKING AND LOSS OF THE VESSEL WITH FIVE  
CREWMEMBERS MISSING AND PRESUMED  
DECEASED SOUTH OF SUTWIK ISLAND, ALASKA  
ON DECEMBER 31, 2019**

**THE SINKING AND LOSS OF THE COMMERCIAL FISHING VESSEL SCANDIES  
ROSE (O.N. 602351) SOUTH OF SUTWIK ISLAND, ALASKA RESULTING IN  
THE LOSS OF FIVE LIVES ON DECEMBER 31, 2019**

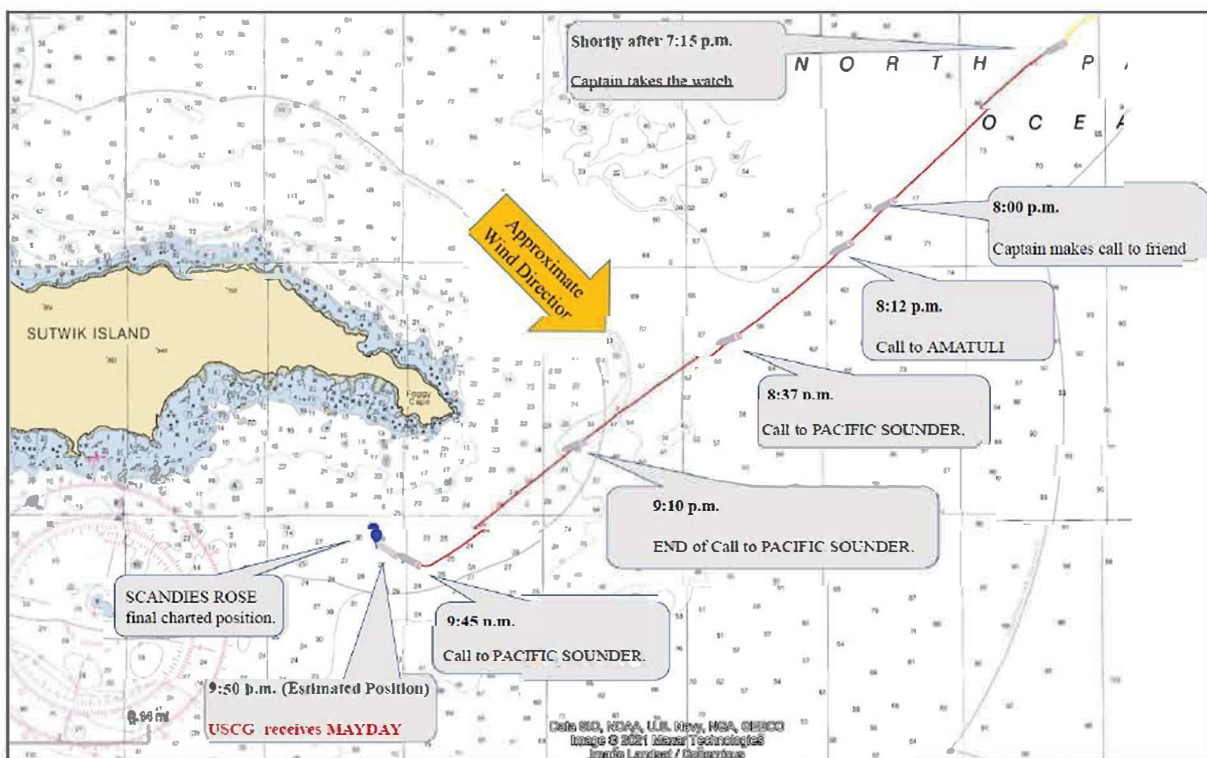
4.1.36. At approximately 9:45 p.m., the SCANDIES ROSE was approximately 2.5 NMs south of Sutwik Island. The vessel turned approximately 50 degrees to starboard towards the shelter of the island, the vessel's speed reduced to about 6 kts, and the vessel held a northwesterly course as indicated in figure 11, below:

Figure 11 – Last segment of the SCANDIES ROSE Captain's watch with significant events highlighted. Wind arrow with the approximate wind direction has been added. (Source Coast Guard)

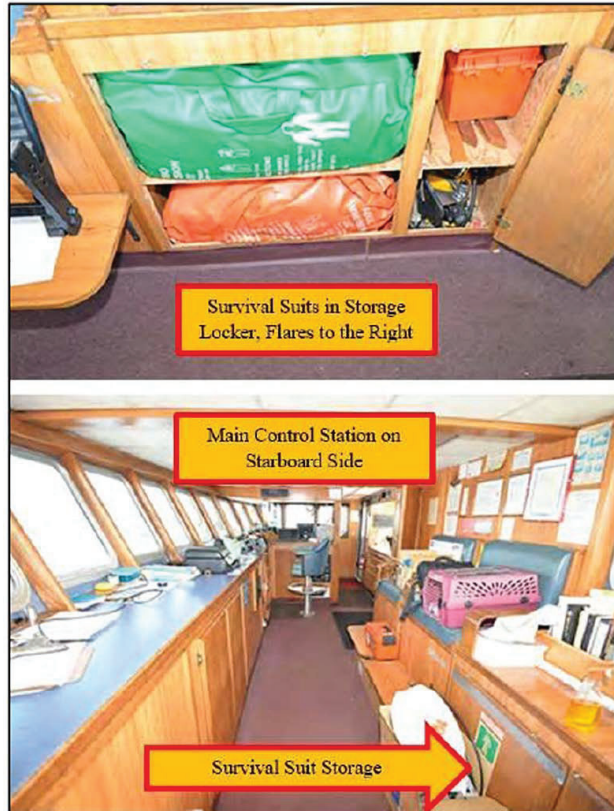
Figure 12 – Location of the survival suits in the wheelhouse of the SCANDIES ROSE. (Source CG Exhibit 004)

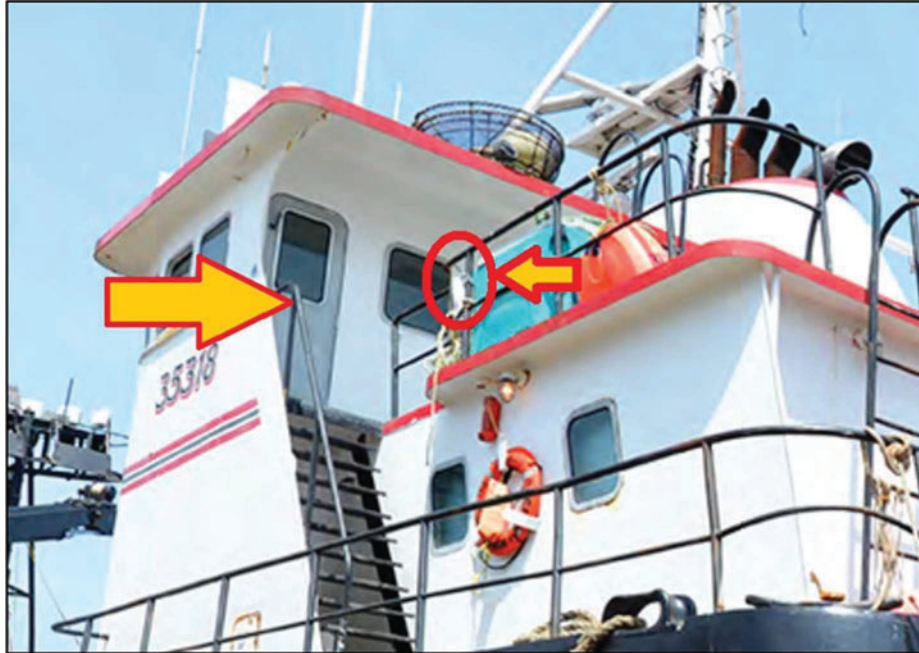
4.1.48. Mr. ██████ assisted Mr. ██████ in closing the long zipper to the survival suit and they exited the wheelhouse through the port side door shown in figure 13.

Figure 13 – Large arrow points to the port side wheelhouse door on the SCANDIES ROSE. The smaller arrow points to the location where the EPIRB was stored in the float free bracket, which is circled in red. (Source CG Exhibit 004, with markup)

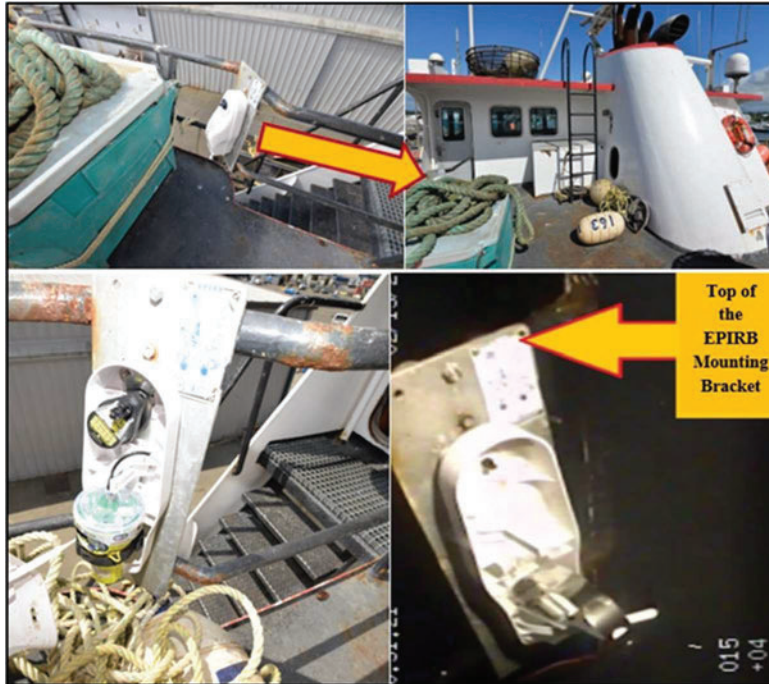
Figure 14 – Composite of photo montage of the SCANDIES ROSE EPIRB. Top left, EPIRB in housing on the inside of top rail aft of the wheelhouse. Top right is the location shown with the yellow arrow in reference to the position in relationship to the port wheelhouse door. Bottom left, the open EPIRB housing during inspection for 2019 Valuation and Condition Survey. Bottom right, the empty housing as seen during underwater site survey conducted by Remotely Operated Vehicle (ROV) in February 2020. (Source – [REDACTED] photos for 2019 Valuation Survey and bottom right, CG Exhibit 008)

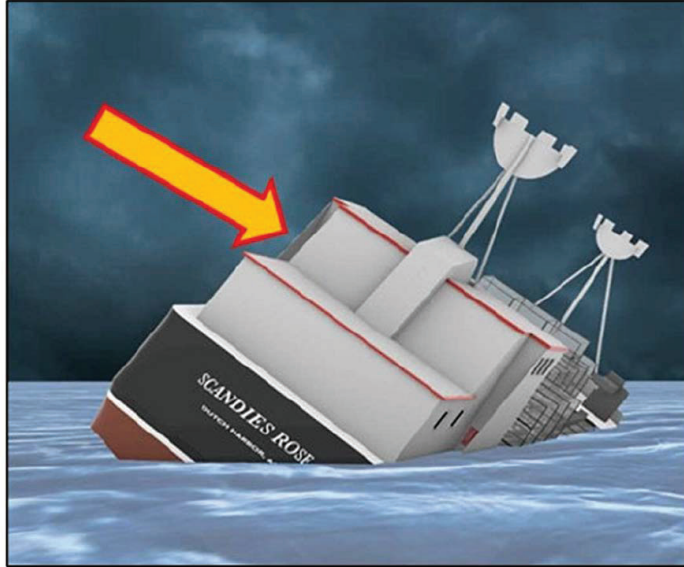
Figure 15 – Yellow arrow points to the approximate location of the survivors when they exited the SCANDIES ROSE wheelhouse port side door. They later moved forward as the vessel began to sink and a wave washed them overboard. The MSC model is displaying an approximate list to starboard of 35 degrees. (Source Coast Guard)

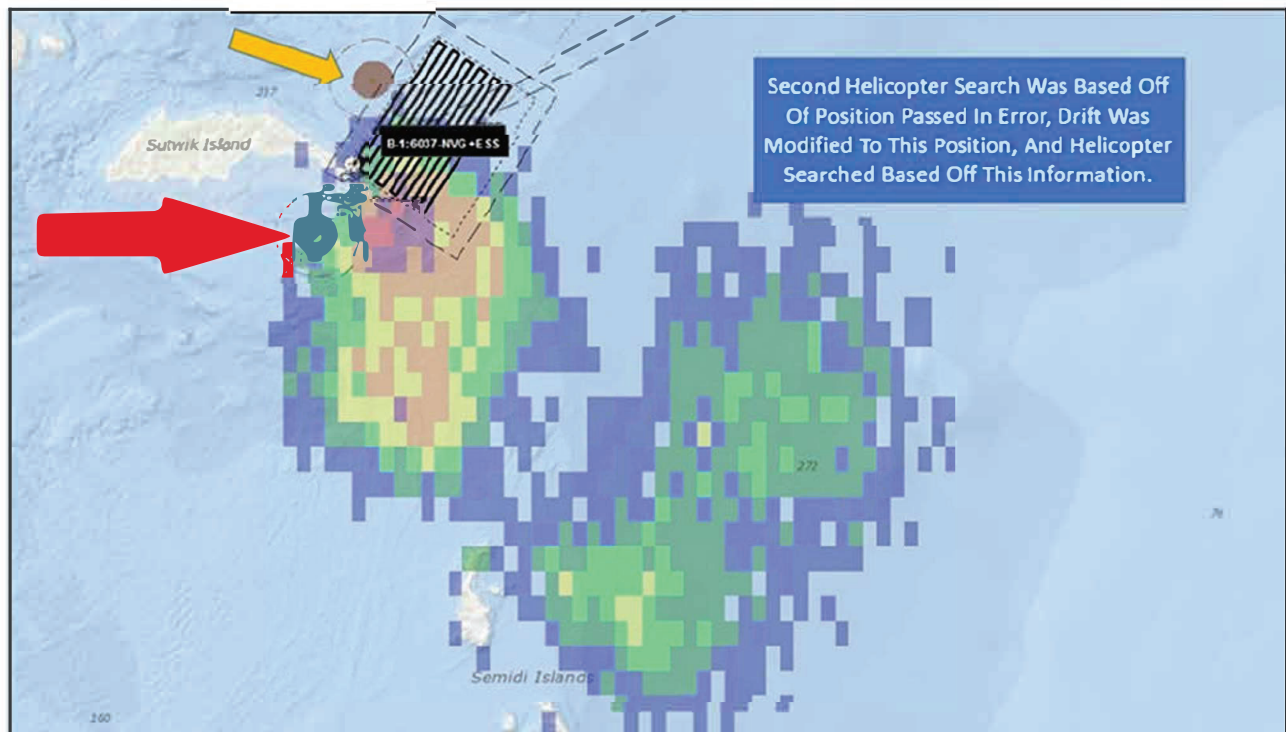
4.1.102. Due to an error in the transposition of the coordinates into the computer modeling software Search and Rescue Optimal Planning System (SAROPS), one search model was built for an area north of Sutwik Island, which was used by the second Coast Guard helicopter, the CG-6037. The SAR Program Manager talked about that error:

Figure 20 – Second search pattern with red arrow indicating the position of the SCANDIES ROSE from the distress radio message. Yellow arrow points to the incorrect position of the liferaft which was used as the center point of search #2. The small colored rectangles represent the computer modeling prediction of the best location for searching based on the computer drift modelling. Red and magenta colors indicate the greatest possible chance of search success based on the modeling of the weather conditions and the characteristics of the search object. (Source CG Exhibit 076, with markups)

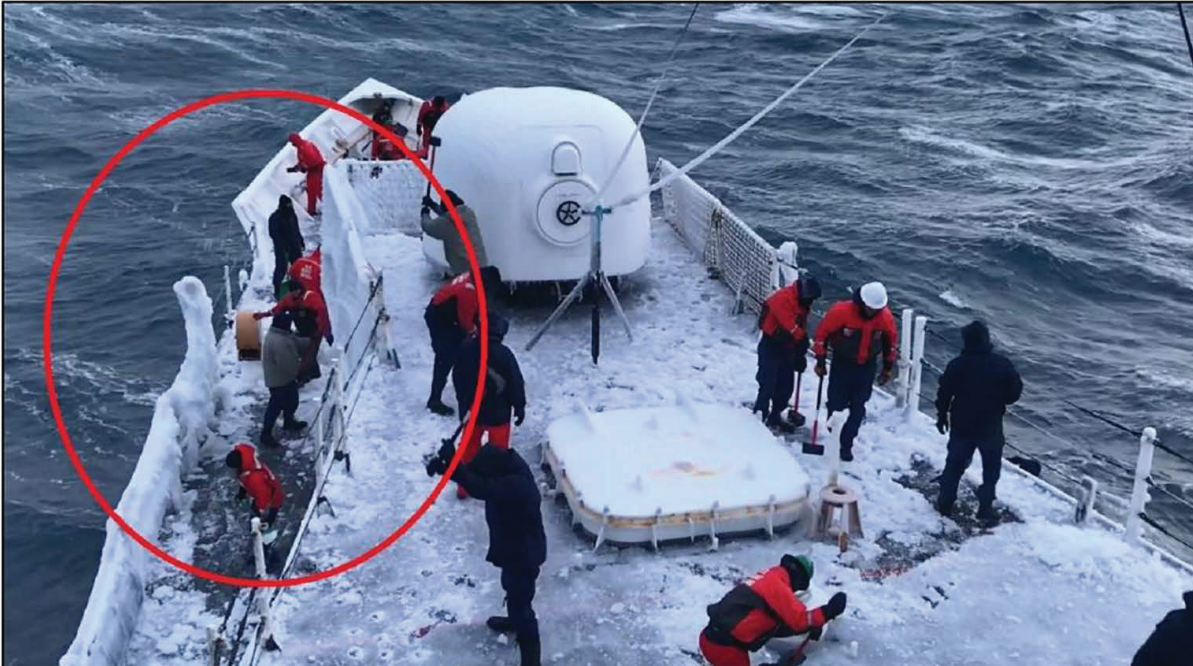
4.1.117.1. The CGC MELLON deployed crewmembers out onto the cutter's deck to conduct manual removal of the ice that had formed on the bow area and superstructure during its transit to the search area. The crew used tools to manually break the ice off rails, deck surfaces, and other fittings. This was done specifically during daylight hours to reduce the risk to the crew.

*Figure 22 – Image of USCGC MELLON crewmembers on the bow of the vessel breaking ice shortly after arriving in the search area. The red circle shows the difference between a de-iced portion of the port side railing and the parts of the ship that had not yet been de-iced highlighting the level of ice accretion the CGC MELLON experienced as it steamed to the SCANDIES ROSE's last known position. (Source Coast Guard Exhibit 095 screen capture, with markups)*

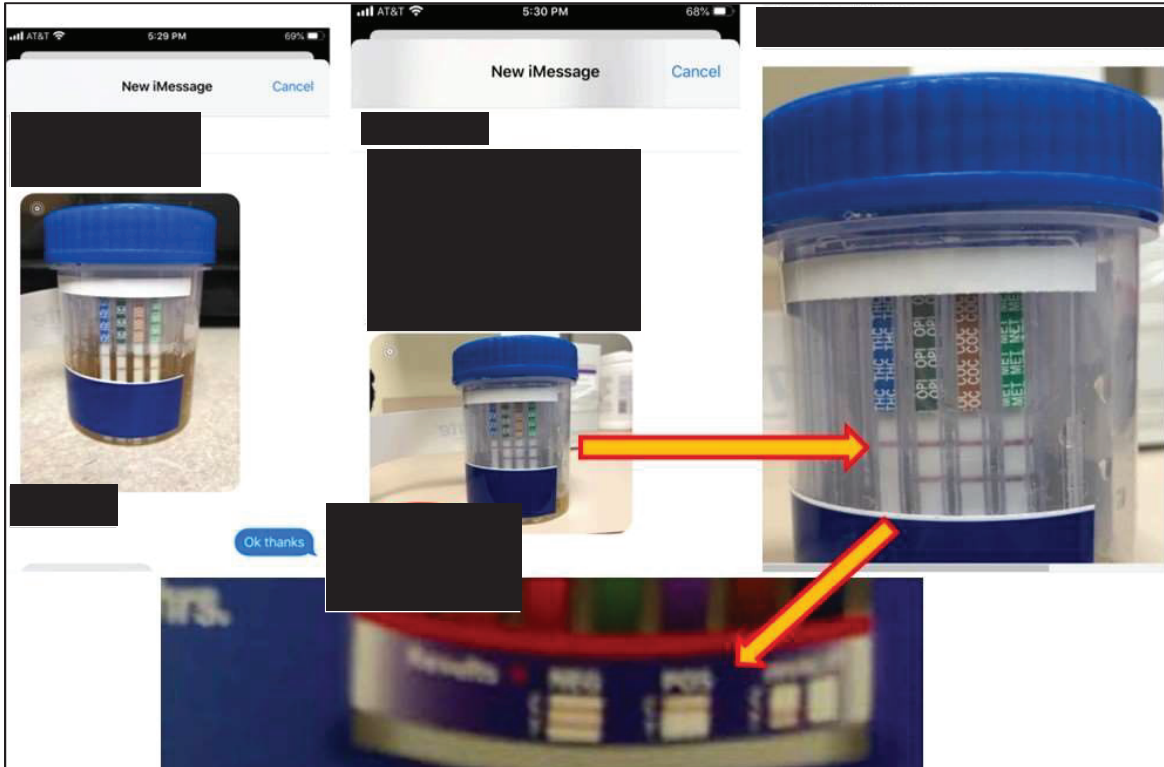
Figure 27 – Results of the post-accident drug test administered to the two survivors. The hospital staff would not drug test the survivors based on hospital protocol. As a result, ██████████ purchased the home test kits upon request of the vessel manager and the crew submitted urine samples, the results were photographed and sent via text message to the vessel manager. The testing was not conducted by a certified lab. (Source: CG Exhibit 080, with markups)

4.2.17. Post-accident drug testing for the survivors was not carried out under controlled conditions by a certified laboratory and a Medical Review Officer did not verify the results.

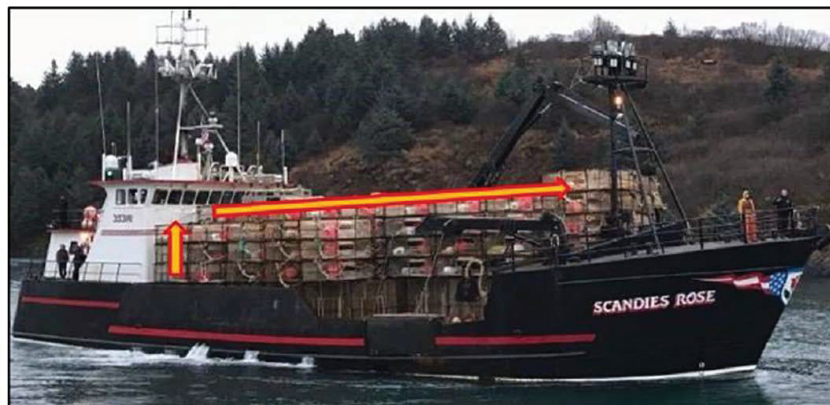
4.2.48. Estimates of ice accumulation on the vessel and the pots were made by the crew from the inside the wheelhouse of the vessel. The only bridge windows that could be seen out of were the two directly in front of the starboard helm station which had heating elements installed. The other windows did not have heating elements and were glazed with a coating of ice making it difficult to see out of them. To accurately assess the accumulation of ice on the forward part of the vessel would require leaving the wheelhouse and going forward to accurately observe the accumulation of ice on the vessel and the pots.

Figure 30 – Arrows indicate the general route a crewmember would have to take to climb up to the top of the pot stack and then go forward to do a full assessment of the ice accumulation on the accident voyage. (Source CG Exhibit 014, with markups)

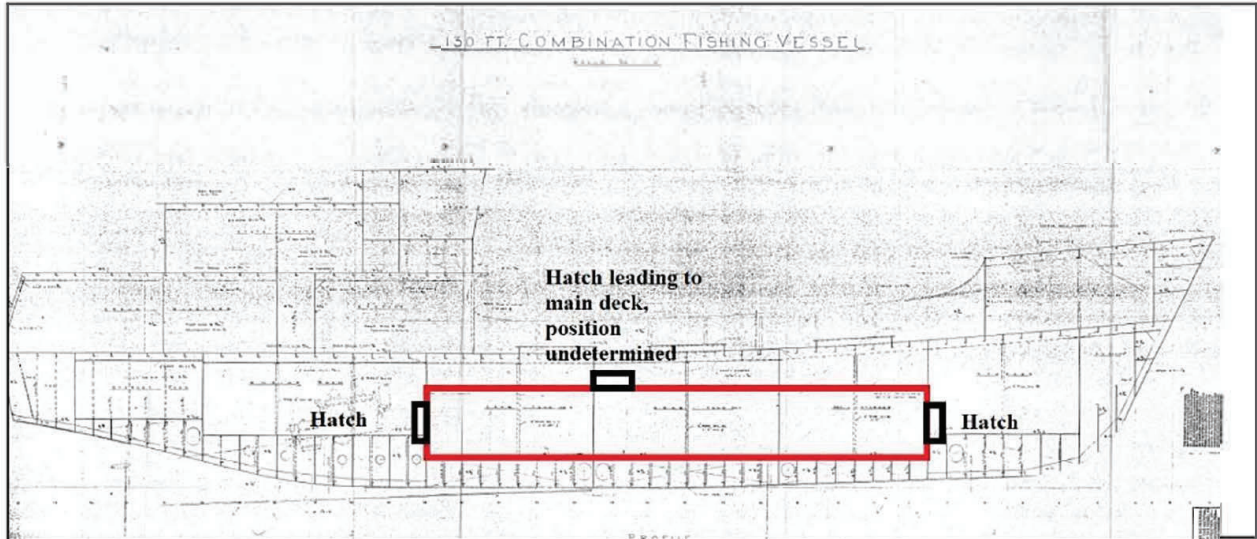
Figure 37 – Approximate position of the pipe alleys that ran down each side of the vessel. There were hatches on each end and there was also one hatch in the top of the pipe alley that was able to vertically access the main deck. Position of that hatch is not precise. (Source CG Exhibit 005, with markups)

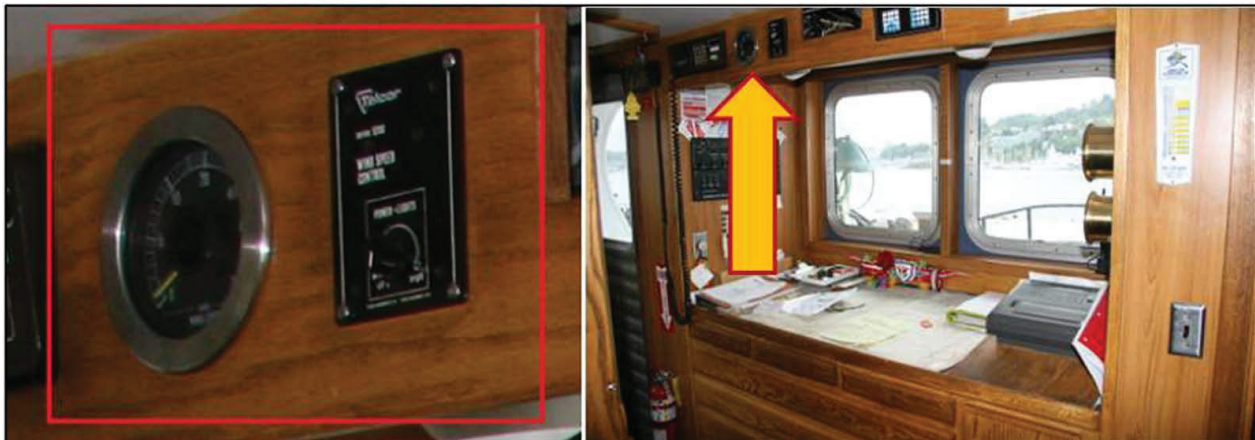
Figure 40 – Wind speed indicator with controller mounted on the upper part of the after-wheelhouse bulkhead of the SCANDIES ROSE that indicate apparent wind speed in knots. The device does not measure wind direction. Also shown in the bottom right of the right picture is the weatherfax, another means to receive weather information. (Source Captain [REDACTED] Survey Photos)

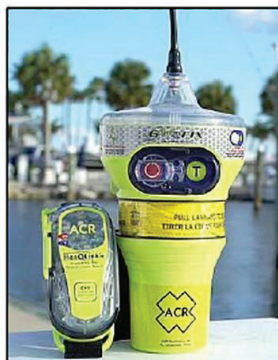
*Figure 43 – To the right is an EPIRB of the type and manufacture that was carried on the SCANDIES ROSE. The EPIRB on the SCANDIES ROSE did not transmit a signal received by rescue forces and the storage bracket was empty when the ROV inspected the wreckage. On the left is one type of personal locator beacon for size comparison. (Source Coast Guard Auxiliary Photo)*

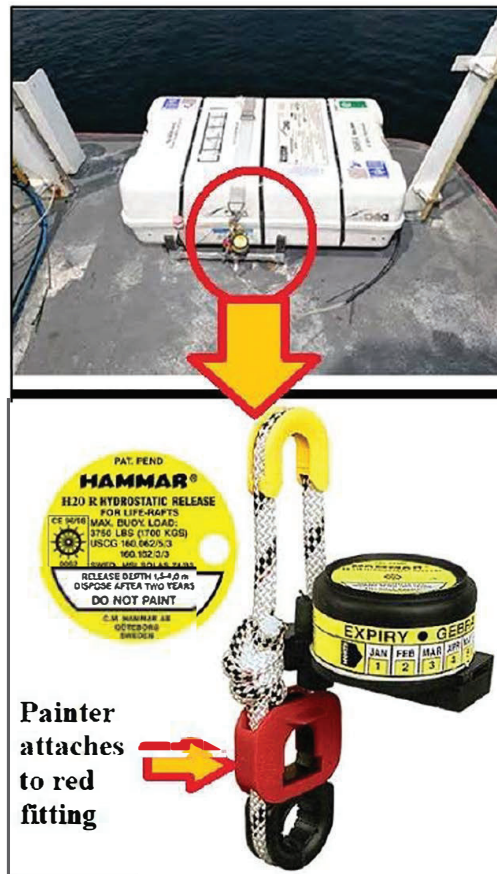
Figure 45 – One of two liferafts on the SCANDIES ROSE. Circled in red is the hydrostatic release device which allows the liferaft to inflate and float free of the vessel as it sank. The close-up of the hydrostatic release device shows the point where the liferaft painter attaches, once the device activates, the raft floats free, inflates and then the painter is released from the device allowing the raft to stay on the surface. (Source CG Exhibit 004 and close-up from the CG D17 Commercial Fishing Vessel Safety Reference Guide [http://www.fishsafewest.info/PDFs/D17CFVSE\\_JobAid.pdf](http://www.fishsafewest.info/PDFs/D17CFVSE_JobAid.pdf))

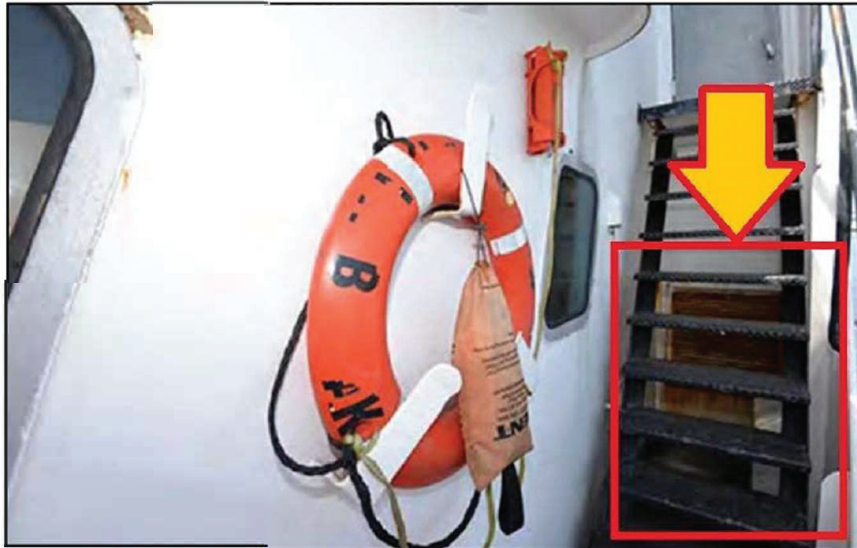
Figure 53– Engine room air intakes under and behind the stairs leading up to the SCANDIES ROSE wheelhouse highlighted by red box and yellow arrow. The air intakes are near the outboard side of the vessel and lead directly down into the vessel’s engine room. (Source CG Exhibit 004, with markup)

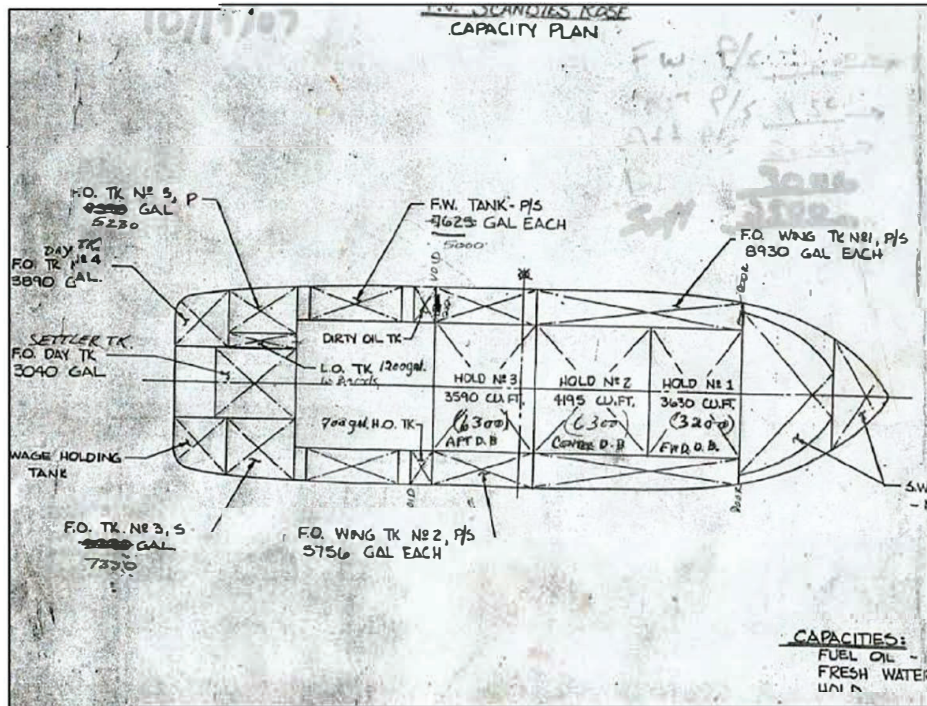
Figure 54 – The tank capacity plan for the SCANDIES ROSE based on plans dated 2007. (Source CG Exhibit 059)

4.2.161. During the course of modeling the vessel, MSC calculated the volumes of many of the tanks to differ from those reported by the Naval Architect. Developing stability

instructions with inaccurate tank quantities can affect the stability limitations imposed on the vessel by a naval architect. The differences between the MSC model and the Naval Architect’s model indicate that deviations in tank load weights were less than 1% of the total displacement of the vessel as shown in the figure below which focuses on the 11 loading conditions captured in the 2019 stability instructions.

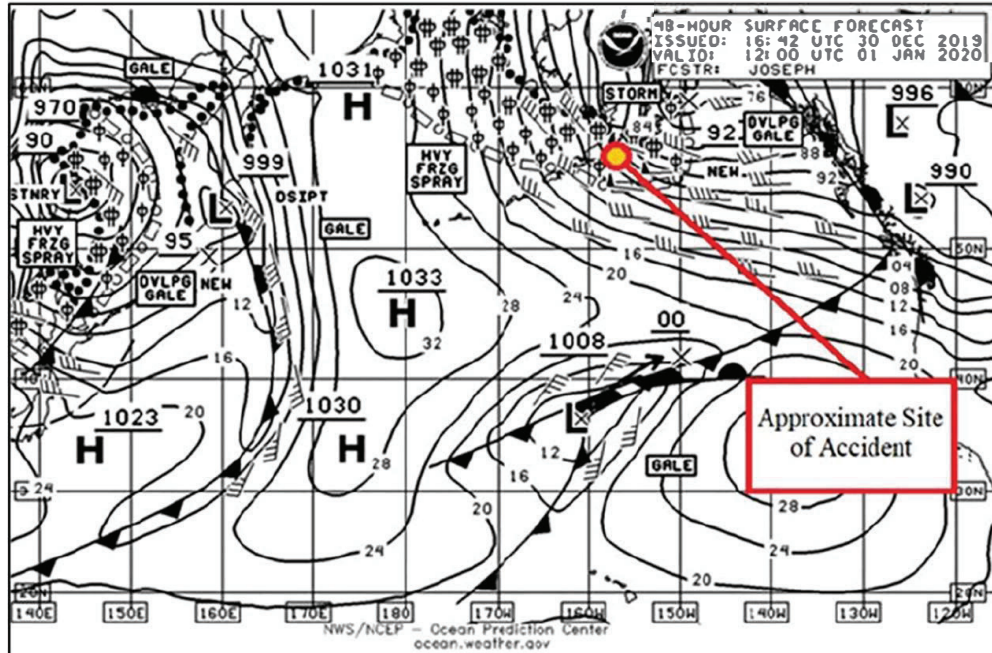
Figure 66 – NWS Ocean Prediction Center High Seas 48-Hour Surface Forecast for 07 42 a.m. AKST, December 30, 2019, thru 3 00 a.m. AKST, January 1, 2020. The storm is located in an area where the isobars are located fairly close to one another and relatively close to the word “storm.” (Source CG Exhibit 028)

Figure 66 was developed by NOAA’s Ocean Prediction Center (OPC) as a tool for mariners. This type of weather map is specifically designed to rapidly allow mariners to understand the weather in the area displayed. It uses standard symbols and format so a mariner can quickly identify dangers. Weather graphic products such as this one would have been available to the Captain of the SCANDIES ROSE via the internet onboard the vessel. In figure 67, below, which is a one of the weather charts that would have been available to the SCANDIES ROSE, the labels for heavy freezing spray (HVY FRZG SPRAY) are prominent and the symbols for the heavy freezing spray on the chart in the vicinity of the accident site along the SCANDIES ROSE voyage track. The actual weather chart does not explain what the freezing spray symbols are and there is no explanation of the amounts of freezing spray that those symbols represent. The NOAA website, which contains a glossary, provides an explanation of the symbols as well as the amounts of anticipated icing per hour for moderate and heavy freezing spray. The information from the glossary page of the NOAA website can be seen at the top of figure 67, below.

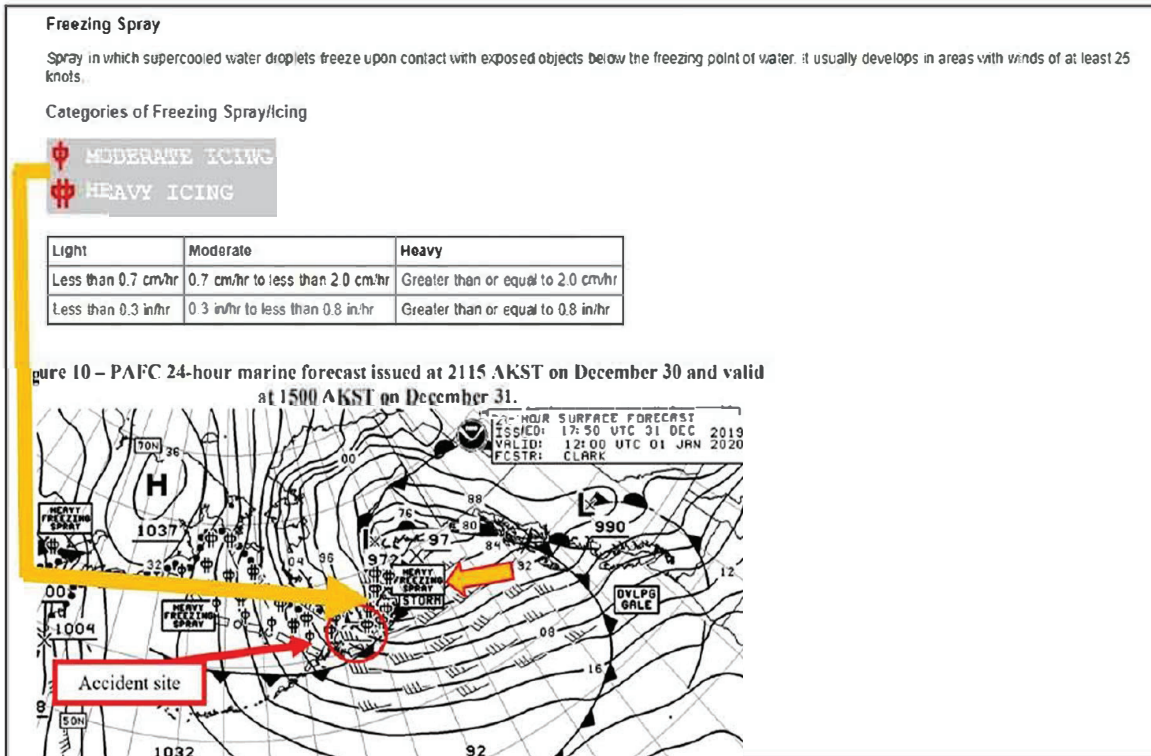
Figure 67 – The top section of this figure is an explanation of the terms and symbols used by the OPC for freezing spray which is contained in the information on its website. One the bottom of the figure is the 48 hour marine forecast issues at 9 15 p.m. on December 30, 2019 and valid at 3 00 p.m. AKST on December 31, 2019. The yellow arrow on the left shows the symbols for moderate and heavy freezing spray and the arrow on the right shows the label for heavy freezing spray, (HVY FRZG SPRAY). (Source OPC, with markups)

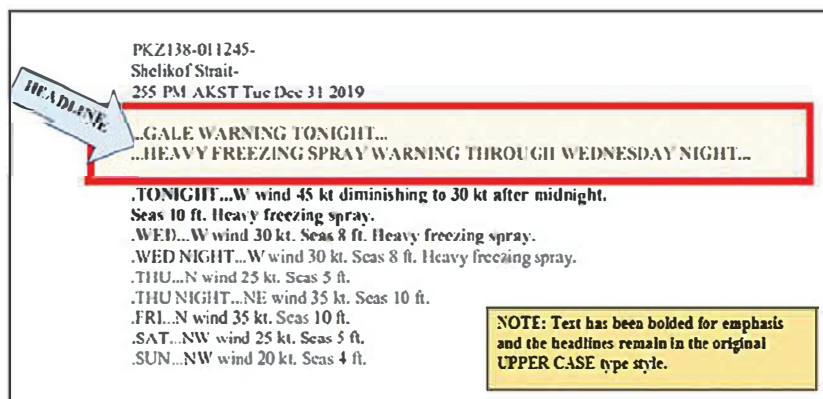
Figure 68 – All capital letter text in the graphical forecast, the “headline” for the urgent information is in the red highlighted box. NWS forecast for the period 2 55 p.m. on December 31, 2019 for the area in the western end of the Shelikof Strait where the SCANDIES ROSE could attempt to seek shelter. (Source NWS, with markup)

In looking at the NWS forecasts, there is no evidence that the crew, or fishing vessel crews in general, knew the difference between a freezing spray forecast and a heavy freezing spray forecast and the greater danger of the heavy freezing spray for rapid and substantial accumulation of ice on the vessel and on the crab pot stack.<sup>146</sup>

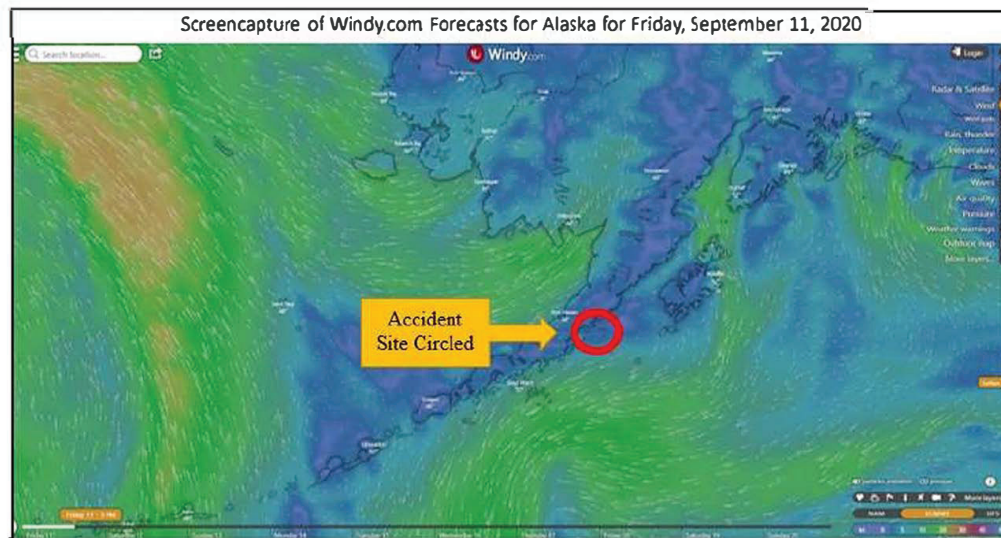
Figure 69 - Screenshot from the Windy.com weather application taken on September 11, 2020 for the region of Alaska. The accident site is circled in red. The colors deepening from yellow to magenta indicate the highest wind speeds and a scale is provided in the application in the lower right corner of the screenshot. (Source CG Exhibit 026, with markup)

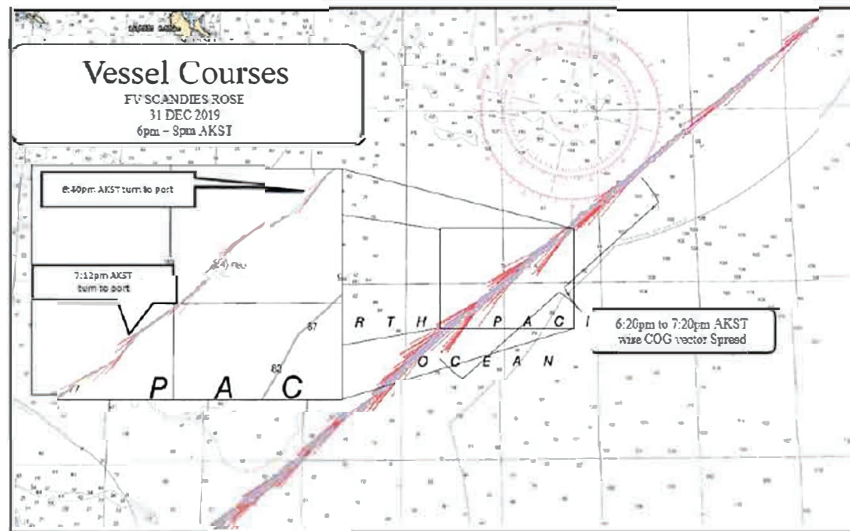
examining the vessel’s AIS data, there is a time from 6:20 p.m. until 7:20 p.m. on the accident day when the vessel yawed on its base course for unexplained reasons. During the course of this investigation, there was no evidence or testimony as to the exact purpose for these very slight heading changes. For that reason, it is unknown if these heading changes were intentional to counteract on-scene conditions or if they were due to natural forces encountered by the vessel without manual adjustments to counter them. In this case, it could indicate worsening weather or icing conditions. Figure 70, below, shows that segment of the AIS track of the SCANDIES ROSE.

Figure 70 – Segment of the SCANDIES ROSE trackline with a focus on the 6:20 p.m. to 7:20 p.m. portion of that trackline showing a pronounced yawing which is a greater deviation from the base track than on any earlier portion of the voyage. Course Over Ground (COG). (Source Coast Guard)

Published guidance on reducing the accumulation of ice on a vessel include reducing the freezing spray by reducing speed, changing course, seeking shelter, or running on an opposite course to reduce the relative wind and the accompanying freezing spray. The more obvious strategy, in this case, would have been to seek shelter from the dangerous conditions earlier during the voyage.

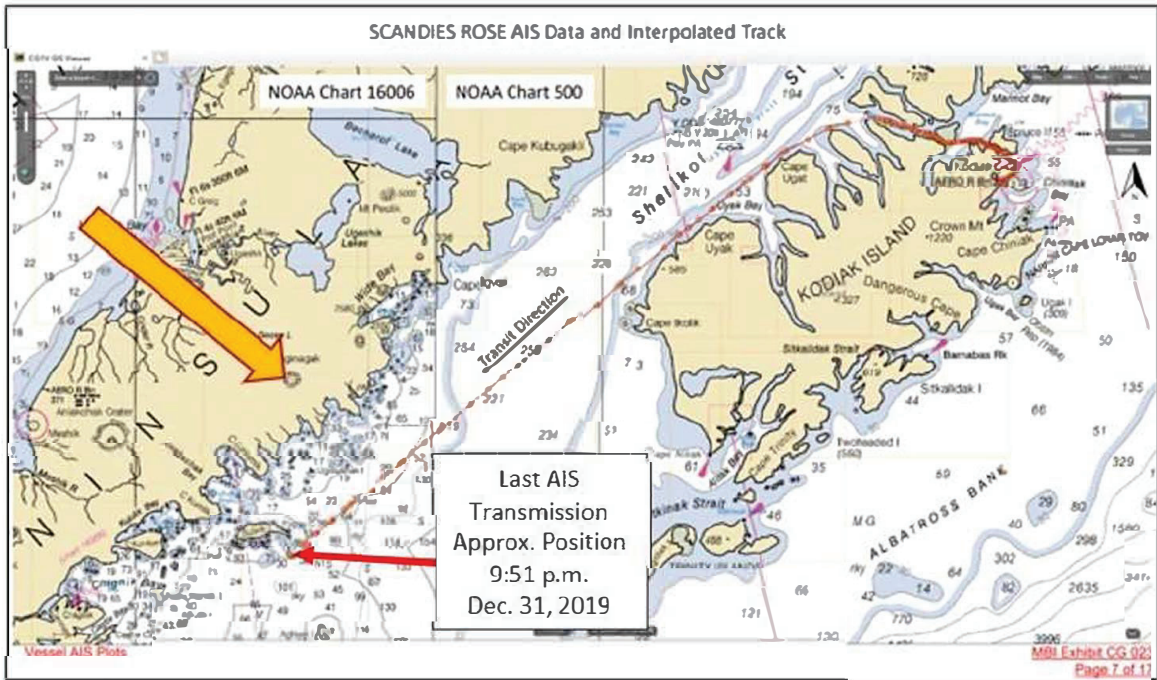
The track of the SCANDIES ROSE would take the vessel down the south side of the Alaska Peninsula towards Sutwik Island as illustrated in the figure below. The Shelikof Strait is a commonly used route for vessels transiting this area. As it travelled along the track, the vessel began to get closer to the Alaska Peninsula landmass off the starboard side and, with it, the general winds blowing towards the vessel from across that landmass. The shoreline to the north is indented with numerous bays and inlets bordered by high mountains which can funnel and intensify the wind into a local condition called a “Williwaw,” a sudden violent squall blowing offshore from the mountainous coast.

Figure 71 – Track of the SCANDIES ROSE on the accident voyage showing the vessel’s proximity to land with the yellow arrow indicating the general direction of the wind. (Source CG Exhibit 023, with arrow as markup)

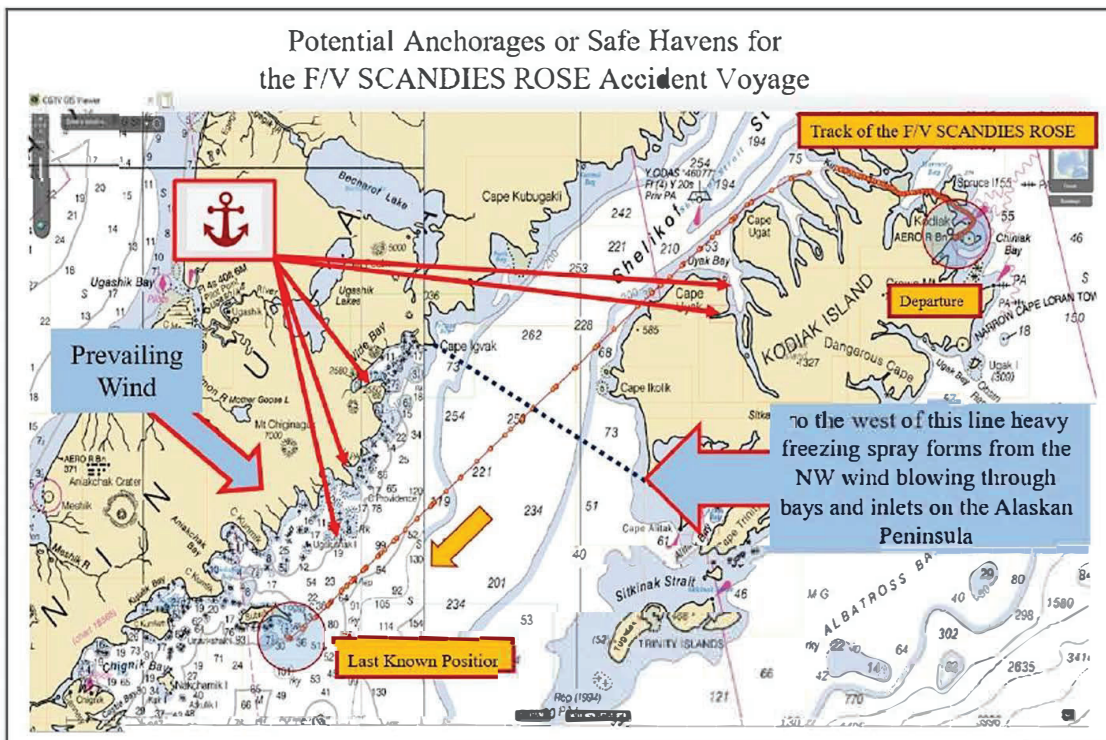
Other captains who testified at the hearing were later queried about the availability of anchorage locations based on the prevailing winds on the route that the SCANDIES ROSE transited. Based on the information they provided, the figure below identifies several of the potential places of refuge along the route.<sup>150</sup> There were a number of potential safe and protected anchorages along the route that Captain [REDACTED] did not take advantage of for the safety of the vessel and crew.

Figure 72 – Nautical chart showing the route of the SCANDIES ROSE on the accident voyage. Positions are marked representing reportedly good anchorages in northwest winds similar to the weather the SCANDIES ROSE was experiencing on the accident voyage. Other bays or inlets along the track were reported to offer poor anchor holding ground in the NW winds the SCANDIES ROSE encountered. To the southwest of the blue dotted line mariners would be expected to experience heavy freezing spray accumulation depending on the weather conditions. The numerous inlets on the south side of the Alaska Peninsula funnel the wind, increase its velocity and can rapidly increase the icing effects on a vessel. (Source Coast Guard)

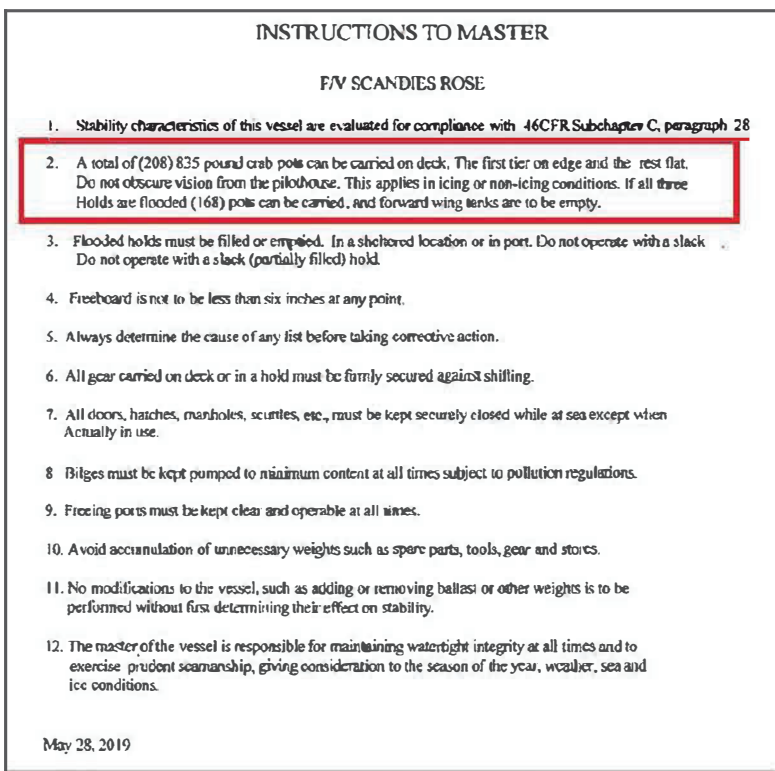
been the Captain's safety margin for the anticipated weather. The instructions to the master from the 2019 stability instructions contained this language: "Do not obscure vision from the pilothouse. This applies in icing or non-icing conditions."<sup>152</sup> That very statement is ambiguous and confusing, as lacks the clarity of detail as to whether the icing applies to visibility or the actual pot load. The stability instructions do not account for the size of the pots used during calculations and the Marine Board believes that the SCANDIES ROSE could not have safely carried 208 of the large pots used on this voyage.

Figure 73 – SCANDIES ROSE's 2019 stability Instructions to the Master provided by the Naval Architect. (Source CG Exhibit 036, with Coast Guard mark ups)

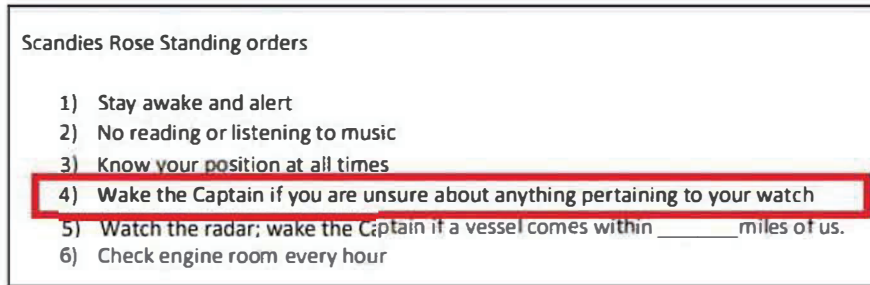
Figure 74 – This example was provided to the MBI as evidence of a typical SCANDIES ROSE Standing Orders from a previous voyage with date unknown (Source CG Exhibit 019, with Coast Guard mark up).

In the absence of clear standing orders, written or verbal, the crew did not wake the Captain as the conditions continued to worsen prior to the Captain’s last watch. Any verbal orders similar to the contents of the example of standing orders contained in figure 74, above, need to be clearly communicated to all of the vessel crew and the intent understood. A verbal set of crew instructions for the navigation watch or standing orders don’t appear to have been discussed when the crew met prior to departure. On standing watch, Mr. █████ testified

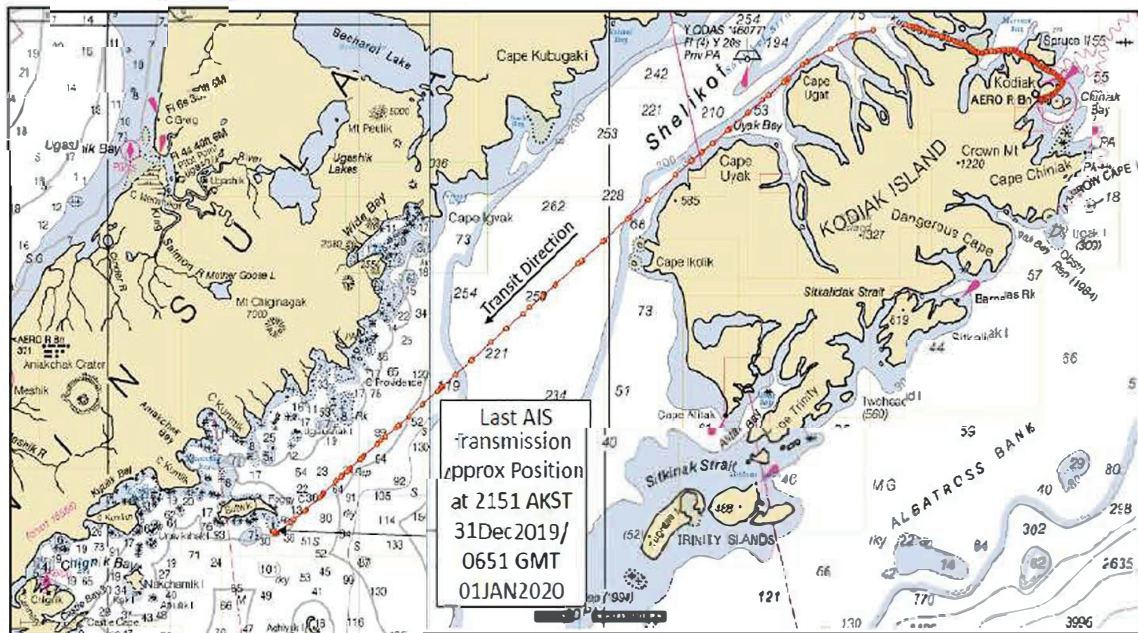
The vessel departed Kodiak on the Captain's watch and went up through Whale Pass into Shelikof Strait and then took a southwest heading. This was the opposite track the vessel took when it returned to Kodiak on the previous voyage. After turning towards the southwest there is little deviation from this track based on the AIS information available up until approximately 9:45 p.m. on the accident night. There is also no deviation on the general speed on that same course line. The track was a more or less direct route to False Pass and then to the fishing grounds. With the prevailing winds and forecast, the Captain could have travelled a slightly longer distance but move more northerly and closer to the Alaska Peninsula's southern coast in case he needed to seek shelter after he passed the available shelters on Kodiak Island's north shore. The track shows he was committed to his goal of reaching the fishing grounds with his late departure.

Figure 75 – This shows the overall track line of the SCANDIES ROSE for the accident voyage. (Source Coast Guard)

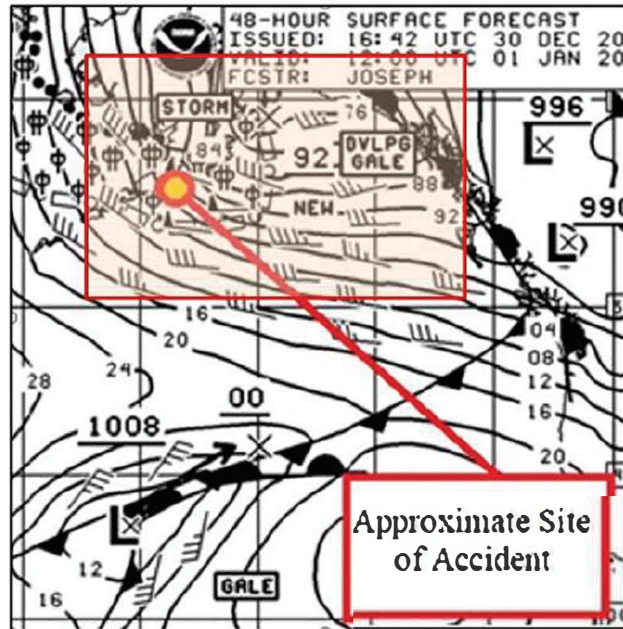
Figure 76 – Enlarged portion of the NWS OPC High Seas 48-Hour Surface Forecast issued at 7 42 a.m. AKST, December 30, 2019 thru 3 00 a.m. AKST, January 1, 2020. The approximate location of the storm is located in an area where the isobars are located close to one another and relatively close to the word “storm.” As indicated by the shaded area in the red box. (Source CG Exhibit 028)

This was a winter weather forecast which mariners operating in Alaska were familiar with, as indicated in multiple Marine Board interviews. Discussions that Captain ██████ had with others and his crew prior to getting underway acknowledged the dangerous forecasted weather but did not indicate that the Captain had a plan in place to reduce the risks associated with the weather.

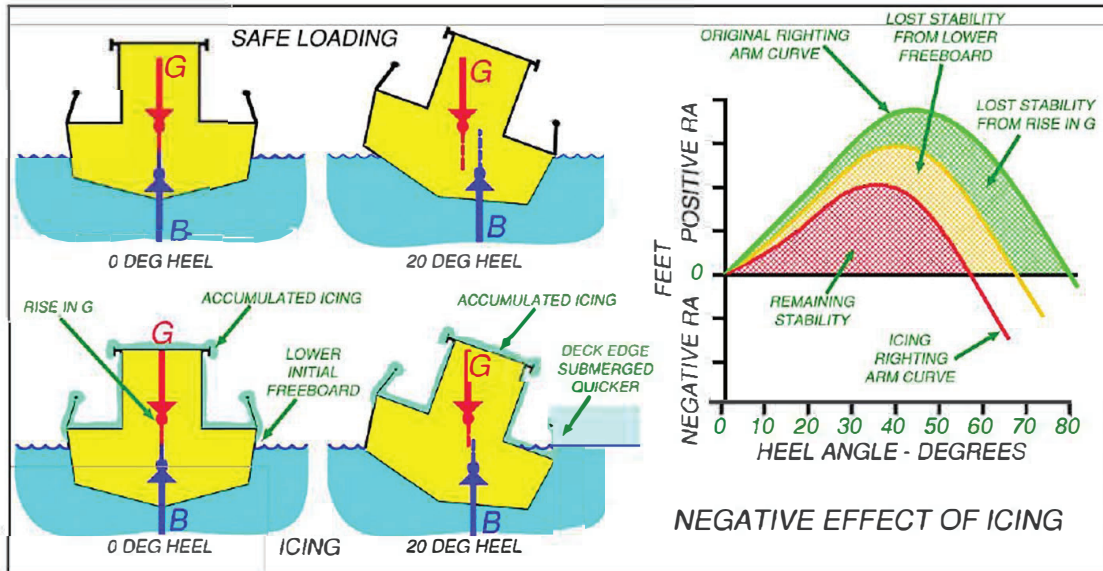
In figure 79, below, it is important to note that the bottom left images show icing. The ice is applied in the image uniformly and the example still illustrates the danger of ice accumulation. As the vessel continues to gain weight above the waterline, the list gradually worsens and the ability for the vessel to right itself decreases, leading to the potential for sudden and catastrophic capsizing. This image, while representing the negative effects of icing, does not take into account the dangers associated with the increased dangers of asymmetrical icing<sup>170</sup> on a vessel.

Figure 79 – An image taken from the Coast Guard’s Stability Reference Guide showing the effects of icing on a vessel which can result in a loss of stability and the potential for capsizing. (Source USCG Stability Reference Guide, [https://www.dco.uscg.mil/Portals/9/DCO%20Documents/5p/CG-5PC/CG-CVC/CVC3/references/Stability Reference Guide.pdf](https://www.dco.uscg.mil/Portals/9/DCO%20Documents/5p/CG-5PC/CG-CVC/CVC3/references/Stability%20Reference%20Guide.pdf))

When icing conditions are encountered, the *Best Practices Guide to Vessel Stability* recommends immediately taking the following corrective actions:

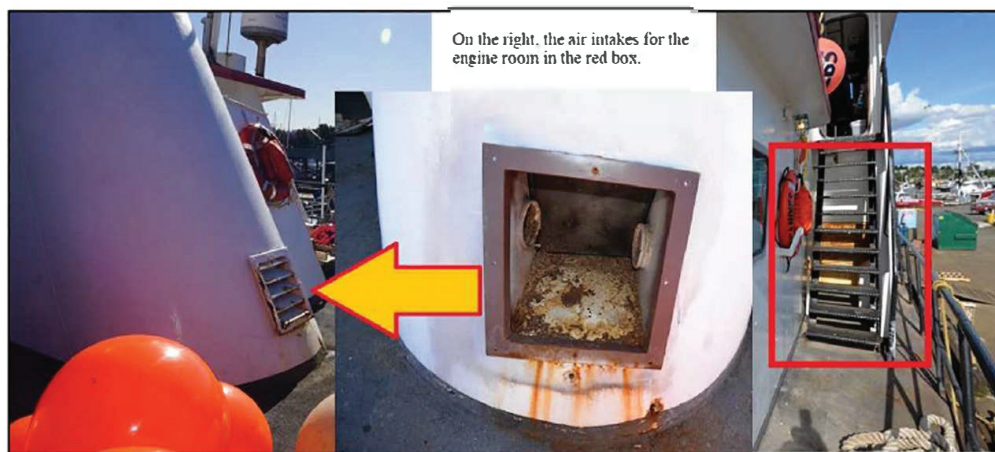
During the course of this investigation, the Marine Board spoke with multiple people familiar with the vessel, and reviewed extensive documentary evidence to examine the vessel's history. The Marine Board concluded that the vent trunks most likely did pass immediately down vertically into the engine room and the MSC's analysis of an approximate 30 to 35 degree downflooding point is accurate. Based on the survivors' testimony, the heel of the vessel was approaching these angles by the time they mustered on the bridge to don immersion suits. The downflooding point identified by the MSC is shown in figure 84, below:

Figure 84 – Composite of images of ventilation system for interior spaces of the SCANDIES ROSE. On the far right starboard ladderwell to bridge with vent intakes shown behind the ladder that are referenced by the MSC Technical Report as being the downflooding point. Center and left, assumed downflooding point described by the Naval Architect in testimony at the Marine Board Hearing. (Source Fisherman Maritime Surveys Inc. photos, various years)

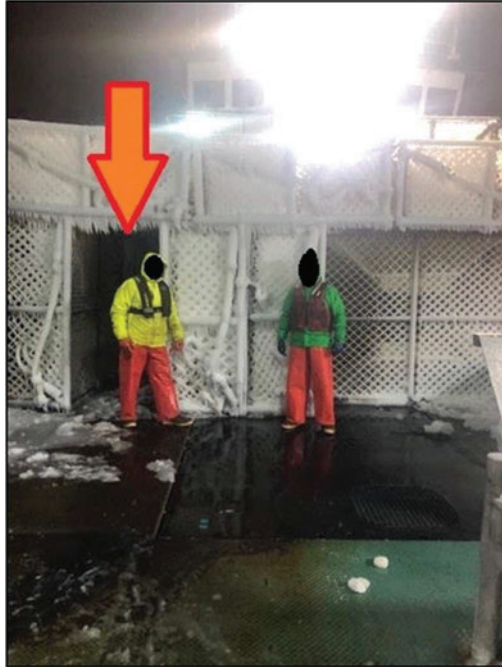
Figure 92 – An alleyway in the lower tier of an unidentified commercial fishing vessel operating in an Alaskan winter. The red arrow points to the alleyway. View is looking toward the stern of the vessel. (Source CG Exhibit 093, with redactions and mark up)

Without an alleyway on deck, the SCANDIES ROSE crew could not walk forward and aft on the main deck but would have to move fore and aft over the top of the exposed pot stack. This could only be accomplished safely in more favorable weather and sea conditions and was an evolution that was still associated with some level of risk. Even getting forward to use the ground tackle or other equipment on the bow would be difficult in an emergency. One of the survivors who loaded the pots testified about loading the SCANDIES ROSE and differentiated between other boats who had created an alleyway or alleyways
