**REPORT OF THE MARINE BOARD OF INVESTIGATION  
INTO THE  
COMMERCIAL FISHING VESSEL SCANDIES ROSE  
(O.N. 602351)  
SINKING AND LOSS OF THE VESSEL WITH FIVE  
CREWMEMBERS MISSING AND PRESUMED  
DECEASED SOUTH OF SUTWIK ISLAND, ALASKA  
ON DECEMBER 31, 2019**

**THE SINKING AND LOSS OF THE COMMERCIAL FISHING VESSEL SCANDIES  
ROSE (O.N. 602351) SOUTH OF SUTWIK ISLAND, ALASKA RESULTING IN  
THE LOSS OF FIVE LIVES ON DECEMBER 31, 2019**

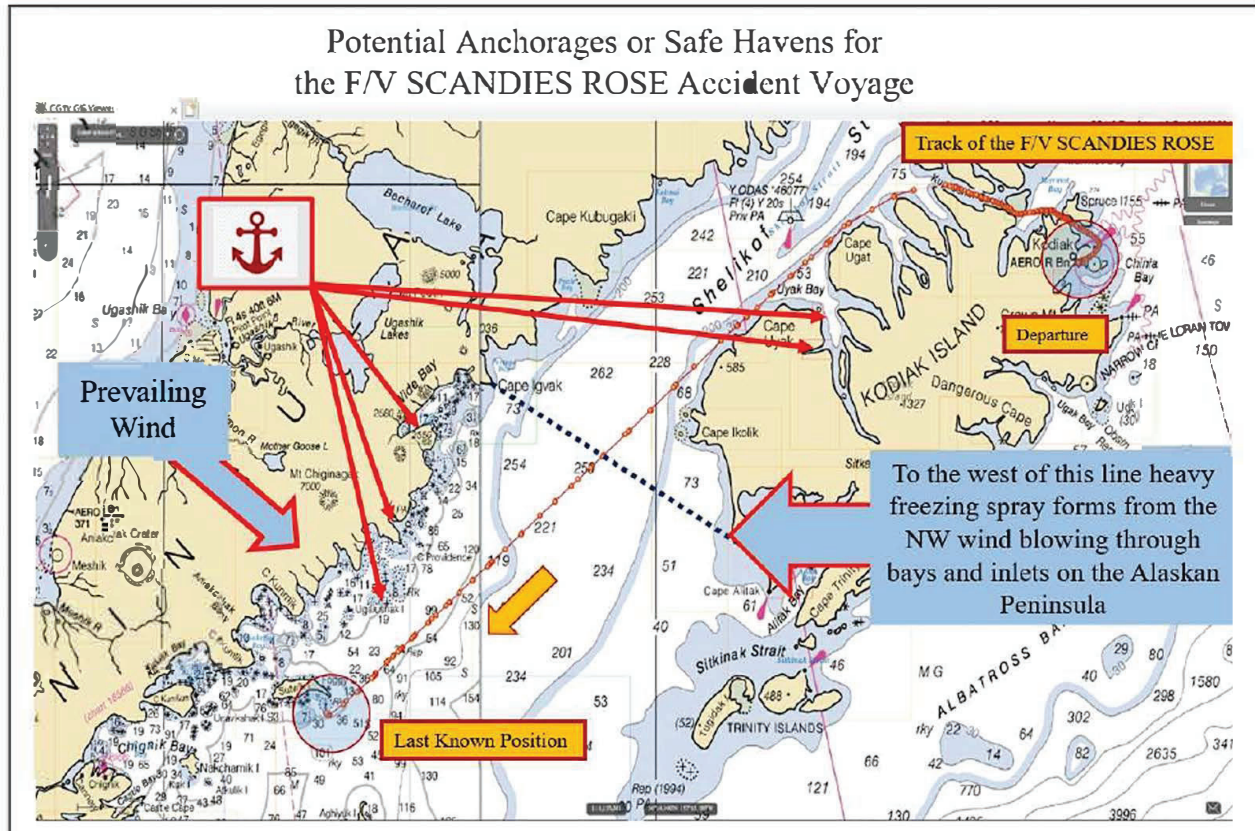
when the Captain assumed the navigational watch and the determination was made that it was too dangerous to send the crew out to remove ice. At that point when the Captain opted to seek the shelter of Sutwik Island, the vessel was already in a dangerous stability condition, listing heavily to starboard.

Figure 93 – Nautical chart showing the route of the SCANDIES ROSE on the accident voyage. Positions are marked representing reportedly good anchorages in northwest winds similar to the weather the SCANDIES ROSE was experiencing on the accident voyage. Other bays or inlets along the track were reported to offer poor anchor holding ground in the northwest winds the SCANDIES ROSE encountered. (Source Coast Guard)

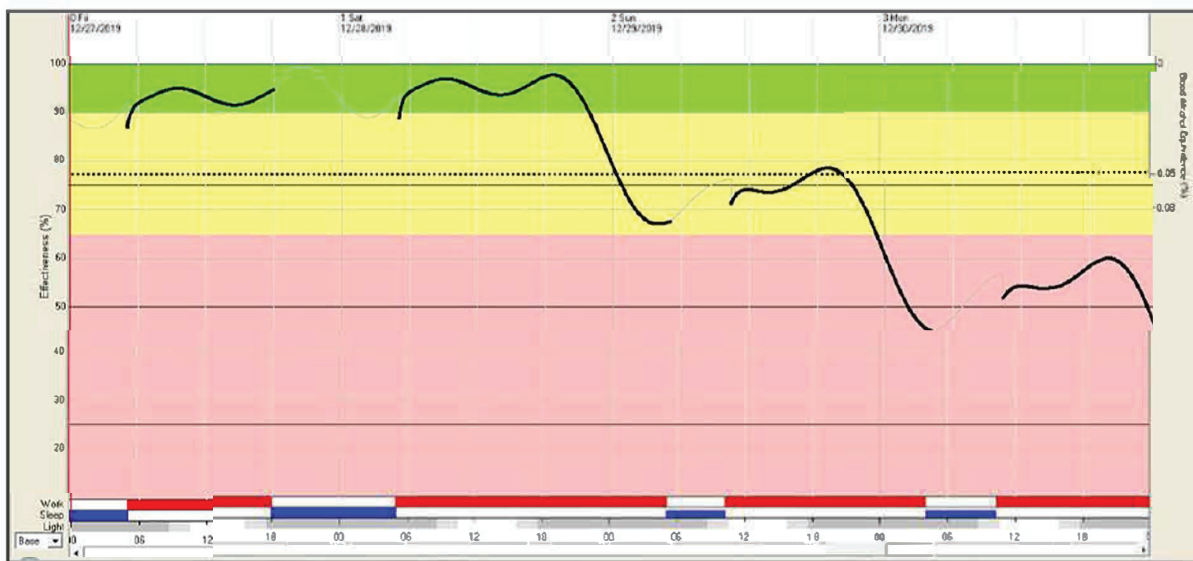
Figure 95 – FAST Analysis documenting the level of fatigue for Mr. █████ based on his work/rest history examined in this investigation. (Source Coast Guard)

The analysis, conducted by the Coast Guard’s Office of Safety and Environmental Health, assumed good “effectiveness” level on day 1 as there was no previous data to consider. Even in the best case scenario, by the end of day 2, the member’s effectiveness decreased as the sleep period was short and taken in periods of the day when the biological clock was not prepared for sleep. The analysis indicated that, at this point, an expected consequence on alertness and performance is comparable to someone under the influence of alcohol—at this level of ‘effectiveness’ this crewmember “would be expected to perform as well as someone with a blood alcohol equivalence of .05” as noted in figure 95, above.<sup>248</sup> Once the vessel got underway and was in transit to the fishing grounds, the analysis recognized that the member had more of an opportunity to get more rest, but some of those hours were not during hours when the body is used to sleeping so the sleep was not considered restorative. The analysis concluded that “any member who experienced a work schedule similar to Mr. █████ probably all the crew who participated in the preparation of the boat, would have experienced similar alertness and performance consequences.”<sup>249</sup>

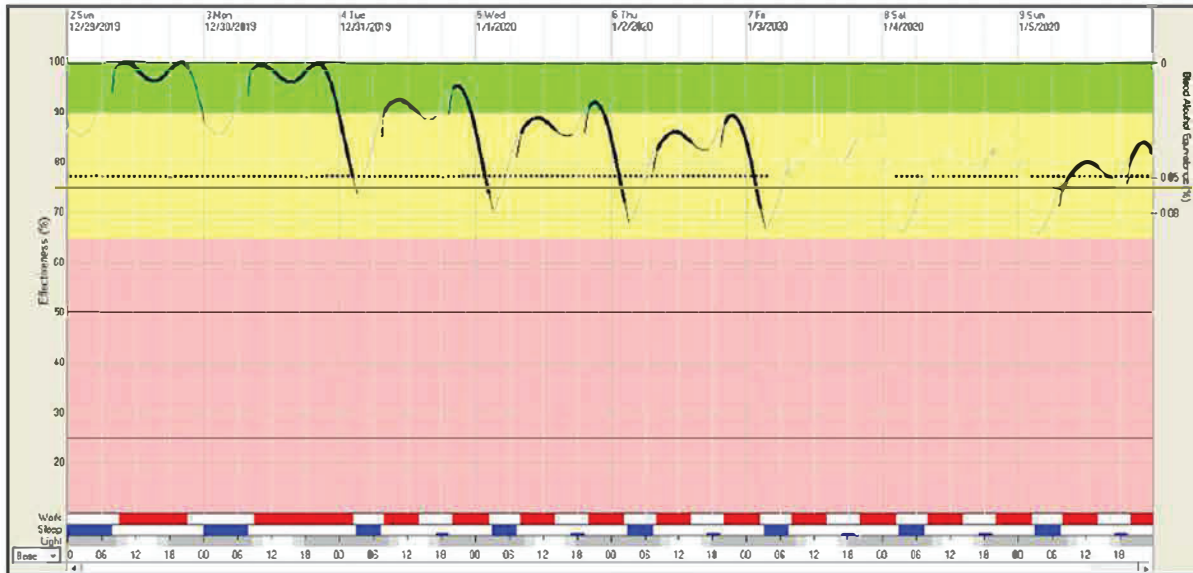
A FAST analysis for Captain █████ used second-hand information provided by survivors and witnesses who engaged Captain █████ prior to and during the voyage accident. Figure 96 shows the anticipated “effectiveness” levels for the vessel Captain assuming he had a more normal work day when in port but then stood six hours of watch and six hours off watch when the vessel was underway. This model was developed for a seven-day period to show the downward trend of effectiveness over time. This “six on/six off” schedule is common practice in commercial maritime world of work. However, that schedule is recognized to contribute to sleep debt since the longest main sleep period is approximately 5.5 hours. This is because while two sleep periods are possible over a 24-hour period, neither is long enough to accommodate ‘full’ sleep restoration.

Figure 96 – FAST Analysis documenting the level of fatigue for Captain [redacted] based on the information available to this investigation. (Source Coast Guard)

The result of the effects of fatigue cannot be precisely determined but may have resulted in an impairment of the critical decision-making during the voyage transit for both the Captain and crewmembers during worsening weather and may have contributed to the failure to seek timely safe refuge before the vessel experienced a catastrophic loss of stability. It may also have contributed to the failure to recognize the dangerous conditions developing such as ice accumulation on the pot stack or other potential sources of list and their resulting consequence on the vessel—the decrease in stability. This delay in identification of the danger to the vessel and lack of further action to mitigate the loss of stability put the vessel and her crew further in extremis.

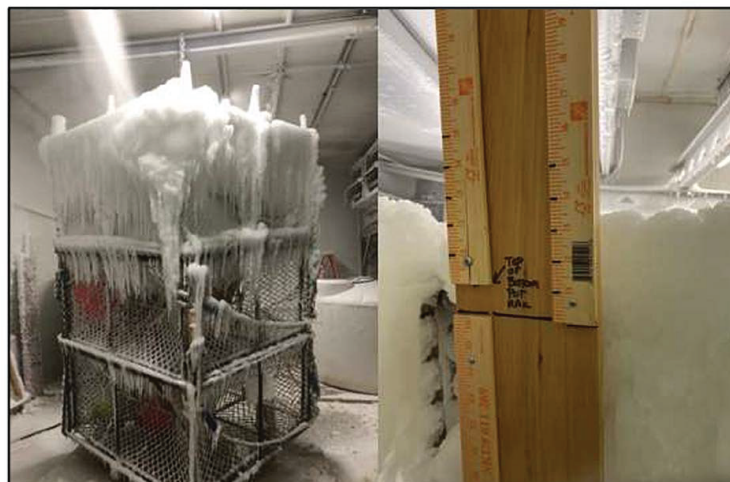
Based on testimony, there was minimal ice build-up on the pot stack with estimates given of a maximum thickness of ice of 2 inches. From the vantage point of the wheelhouse windows on the starboard side of the vessel, the viewer forward would only be slightly higher than the forward top of the pot stack. During the subsequent ice accretion testing conducted at the U.S. Army Corps of Engineers testing facility in Hanover, NH on behalf of the Coast Guard RDC, it was difficult to measure the thickness of ice on a crab pot because the icing removes the frame of reference, the solid steel frame of the crab pot. Figure 97, below, illustrate the difficulty of accurately identifying the thickness of ice on a crab pot in the testing chamber. On board the SCANDIES ROSE, from the wheelhouse to the forward end of the pot stack was a distance of approximately 50 to 65 ft and it would be difficult to determine the thickness of the accumulated ice once a white sheet of ice began to cover the pots.

*Figure 97 – These images demonstrate the difficulty in determining the thickness of ice in crab pots being subjected to freezing spray in a -15° F chamber during the ice accretion testing in September 2021. Left, a three pot stack with a significant accumulation of ice. Right, a ruler that is used to accurately measure the thickness of ice that uses the bottom of the three foot high crab pot as a point of reference to measure the thickness of the ice accurately. (Source Coast Guard)*

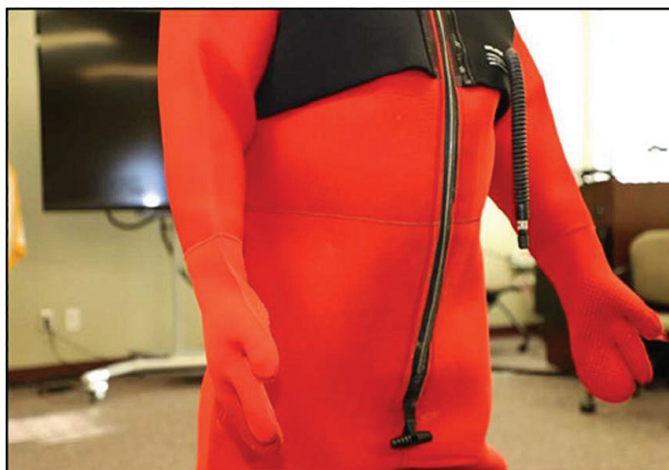
compromised, as the suits have a three-finger mitten style hand covering which is permanently connected to the arm structure of the suit. The tradeoff between dexterity and hypothermia protection is a design challenge and these suits conform to existing regulations in terms of design and construction. However, the survivors were able to get to the inventory of the equipment pack, launch flares, and signal the rescue helicopter with a flashlight. It appears they successfully completed these tasks despite the difficulty with manual dexterity and the immersion suits functioned as intended protecting them from moderate to severe hypothermia.

*Figure 102 – SCANDIES ROSE survival or immersion suit showing the three-finger glove which is attached to the neoprene arm of the suit. The three-finger glove protects the hand from hypothermia but compromises manual dexterity for tasks like opening buckles or activating flares. (Source CG Exhibit 103)*

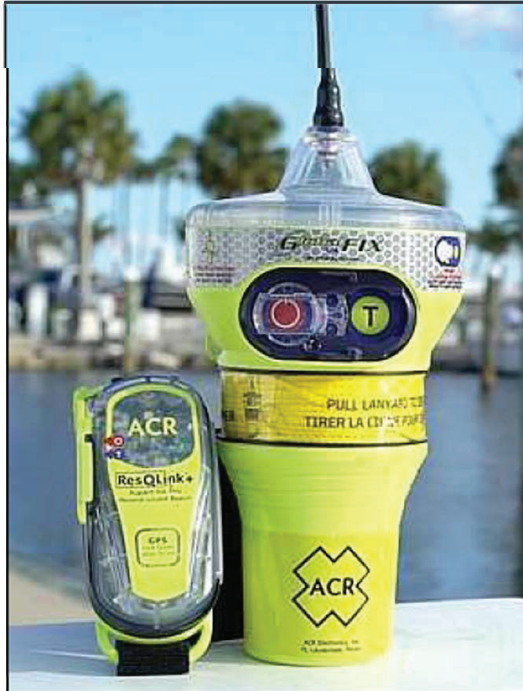
Several high profile distress cases of recent years have highlighted the use of PLBs as a means to rapidly locate people in distress in the marine environment. Both, the Coast Guard and the National Transportation Safety Board have advocated for the use of the devices in recent high profile accident safety recommendations. Currently, these devices are not a mandatory safety item for any commercial or recreational vessels. As far as the investigation can determine, no member of the SCANDIES ROSE crew owned a PLB as part of their personal safety equipment, nor were any issued by the operator of the SCANDIES ROSE for crew use.

Figure 104 – On the left, is an ACR Electronics Inc. version of a PLB that could have been carried by the crewmembers on the vessel. On the right of the same image is an EPIRB of the type and manufacture that was carried on the SCANDIES ROSE. The figure gives a perspective as to the size of the devices in comparison to one another. (Source Coast Guard)

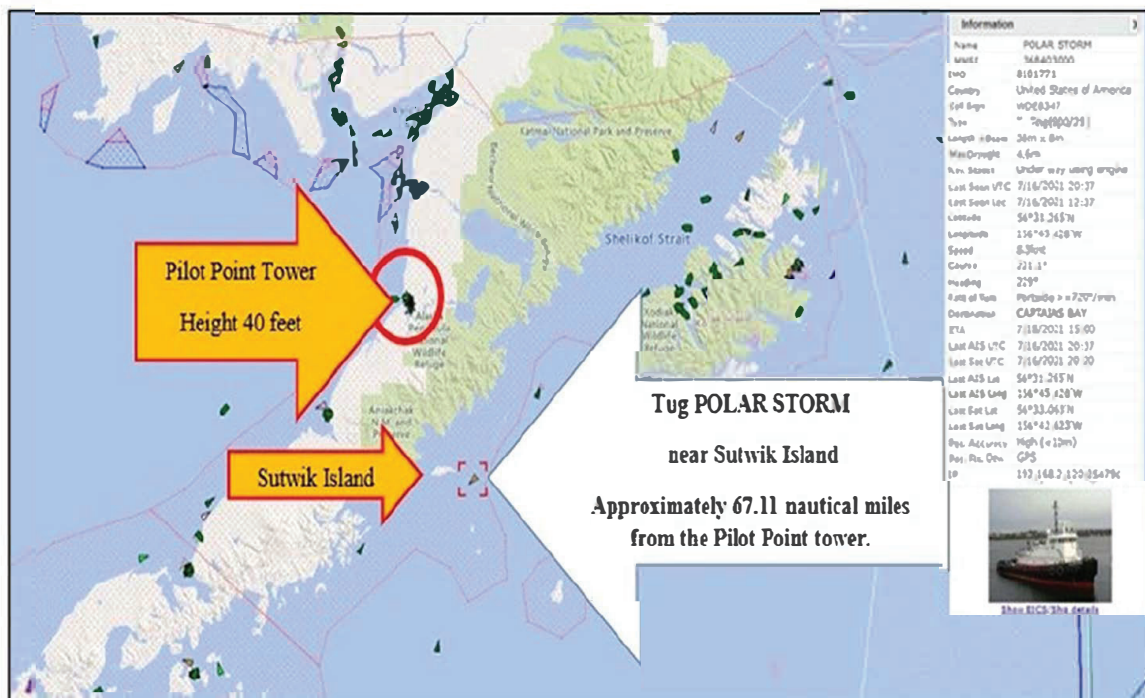
In support of the Marine Board, the Marine Exchange of Alaska, identified a vessel's AIS signal, the commercial tug POLAR STORM, and the Marine Exchange's site antennas picked up an AIS ship target in July 2021 close to where SCANDIES ROSE sank off Sutwik Island.<sup>264</sup> To illustrate the potential propagation of DSC based VHF radio signals figure 106, below, shows that one of the Marine Exchange of Alaska sites at Pilot Point received the VHF/AIS radio signal for the tug POLAR STORM at a distance of 67.11 NM with an antenna with a height of 40 ft. It is unclear what the meteorological conditions were, or time of day the Marine Exchange of Alaska successfully received this message. Pilot Point is the site due North of POLAR STORM on the Bering Sea side of the Alaska Peninsula and it is indicated by the orange arrow in figure 106.

Figure 106 – Position of the POLAR STORM derived from a VHF based AIS signal and received at a Marine Exchange of Alaska 40-foot-high radio tower at Pilot Point, 67.11 nautical miles north of the POLAR STORM. The height of the radio antennas on the POLAR STORM are approximately the same as on the SCANDIES ROSE. This illustrates the potential for VHF based DSC distress alerts to be received by vessels and shore stations. The green symbols on the chart are AIS equipped vessels. (Source Marine Exchange of Alaska, with mark ups)

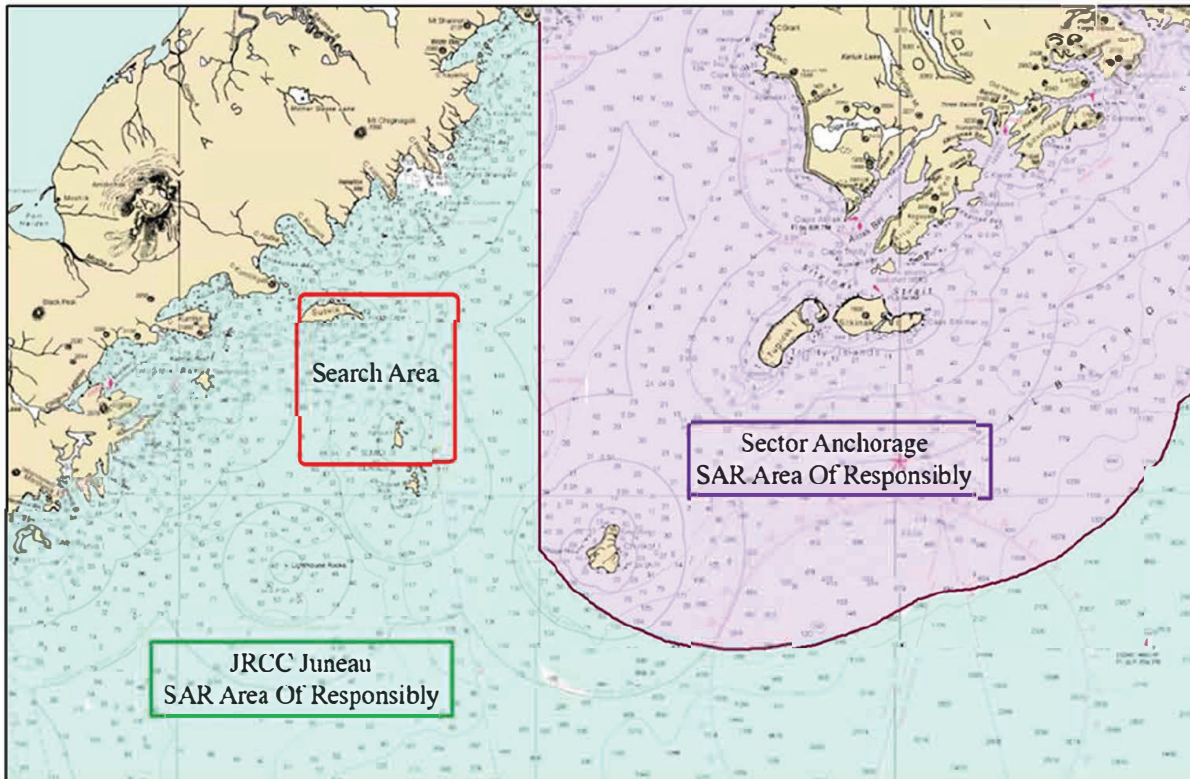
Additionally, Sector Anchorage should have never been assigned as the SAR Mission Coordinator for this case, or had primary control of the SAR operations. The LKP for the SCANDIES ROSE clearly fell outside of Sector Anchorages SAR response AOR and in a region that JRCC Juneau retains SMC. The CDO at D17 should have taken extra effort to plot the position, and verify whose SAR geographic AOR the case fell in. The shift of SMC between D17 and Sector Anchorage took valuable attention for the SAR planners and created confusion at Air Station Kodiak, which led to delays.

Figure 107 – Search and Rescue Areas of Responsibility in relation to Search area. (Source Coast Guard)

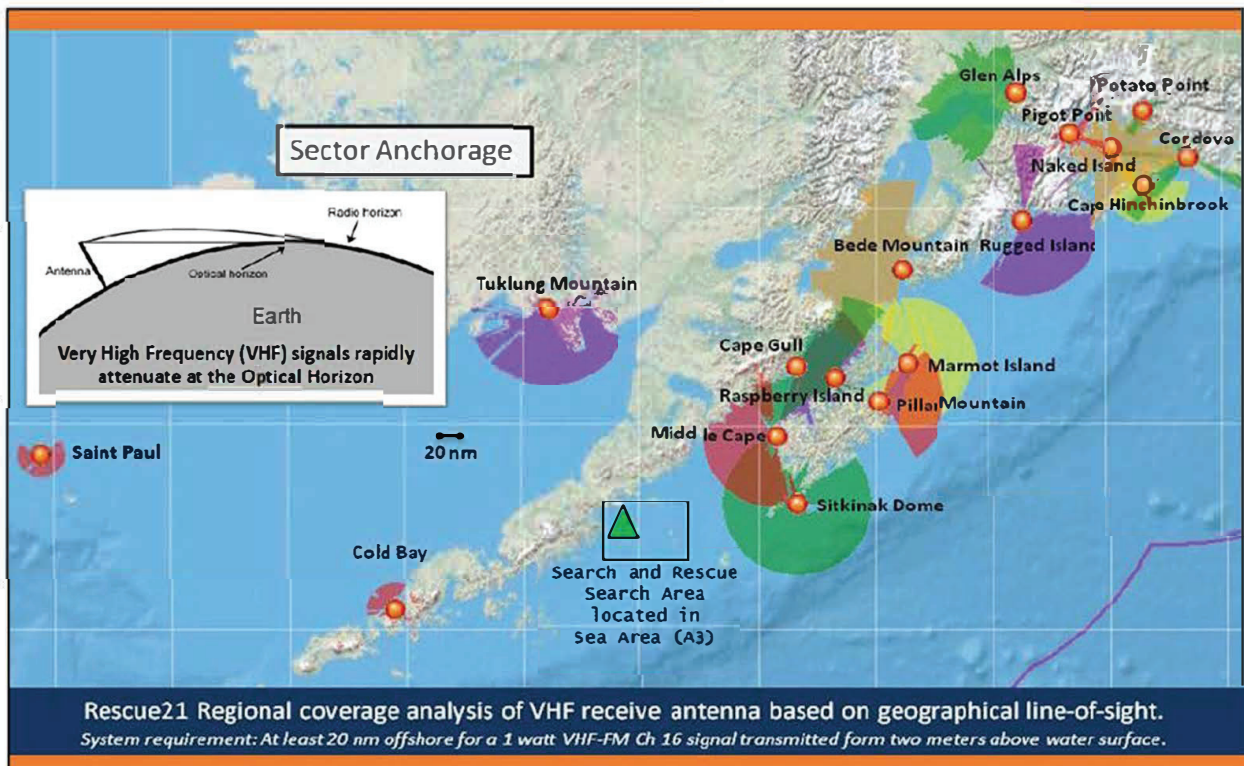
The current R21 AK system does not meet Sea Area A1 radio coverage for VHF FM. There are significant gaps in the baseline system, but additionally there are significant gaps due to maintenance, physical distance between radio towers, and system capabilities. The limited VHF-FM radio coverage coupled with a lack of cellular telephone coverage degrades communications capabilities in the Juneau SRR. For this reason, the HF radios that the Coast Guard maintains are vital to the Coast Guard SAR mission in Alaska. As in this case, at the time of the accident, the Coast Guard maintained an active listening watch on the HF radio network and answered high frequency calls.

Figure 108 – R21 AK Coverage graphic depicting the gap in coverage along the Alaska Peninsula. (Source CDR Nassar, Exhibit CG 109)

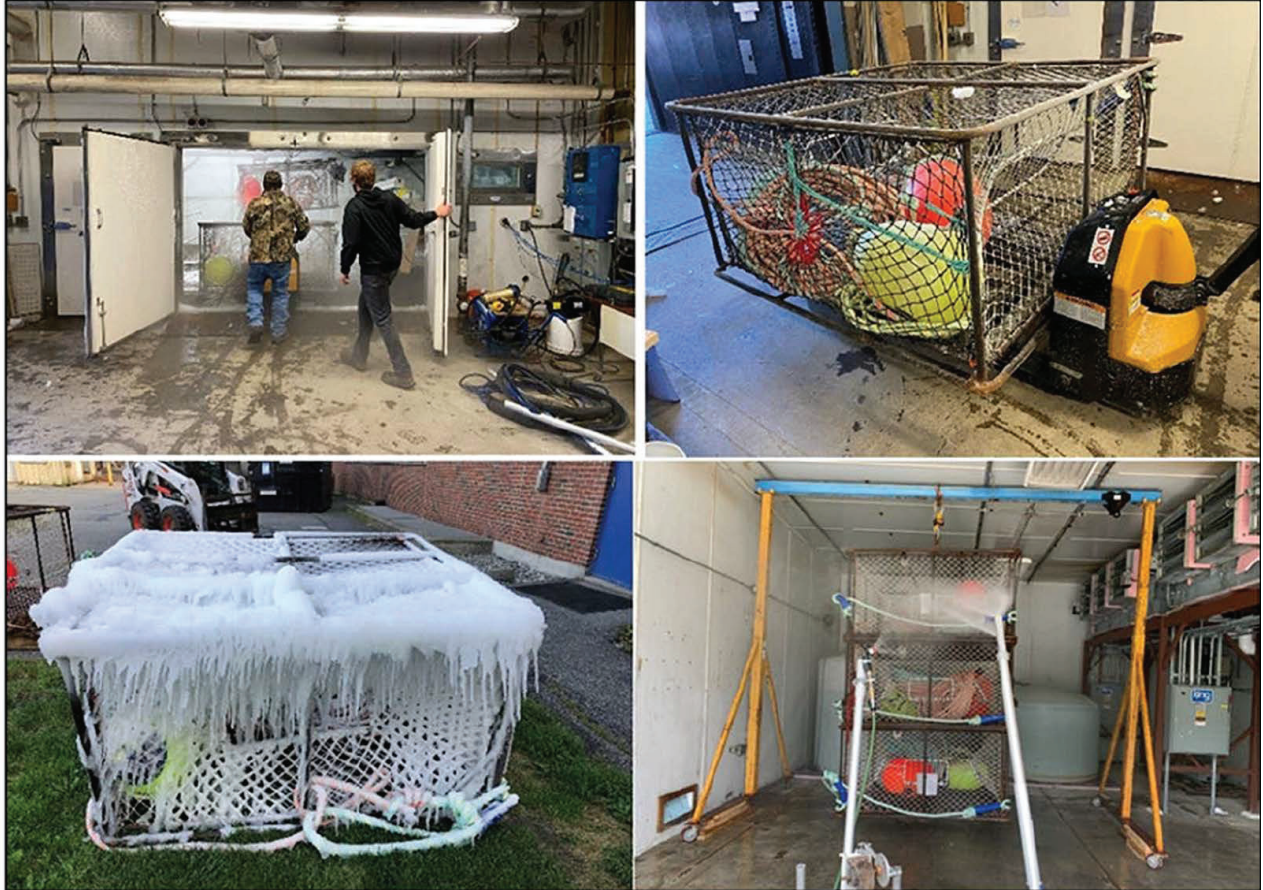
*Figure 109 – Testing at the CRREL facility in Hanover, NH in September 2021. In this composite of testing photos, top left two technicians enter the smaller of the two test chambers to set up for two vertical pot stack testing. Top right one of the pots with the associated gear being maneuvered into the test chamber. Lower, left a single pot after removal from the chamber showing the formation of ice on the single pot. Lower right inside the larger chamber with a triple pot stack hanging from the load cell. In the foreground are the two oscillating sprayers directing saltwater spray onto the triple pot stack based on the configuration requirements in the test plan matrix of tests. (Source Coast Guard)*

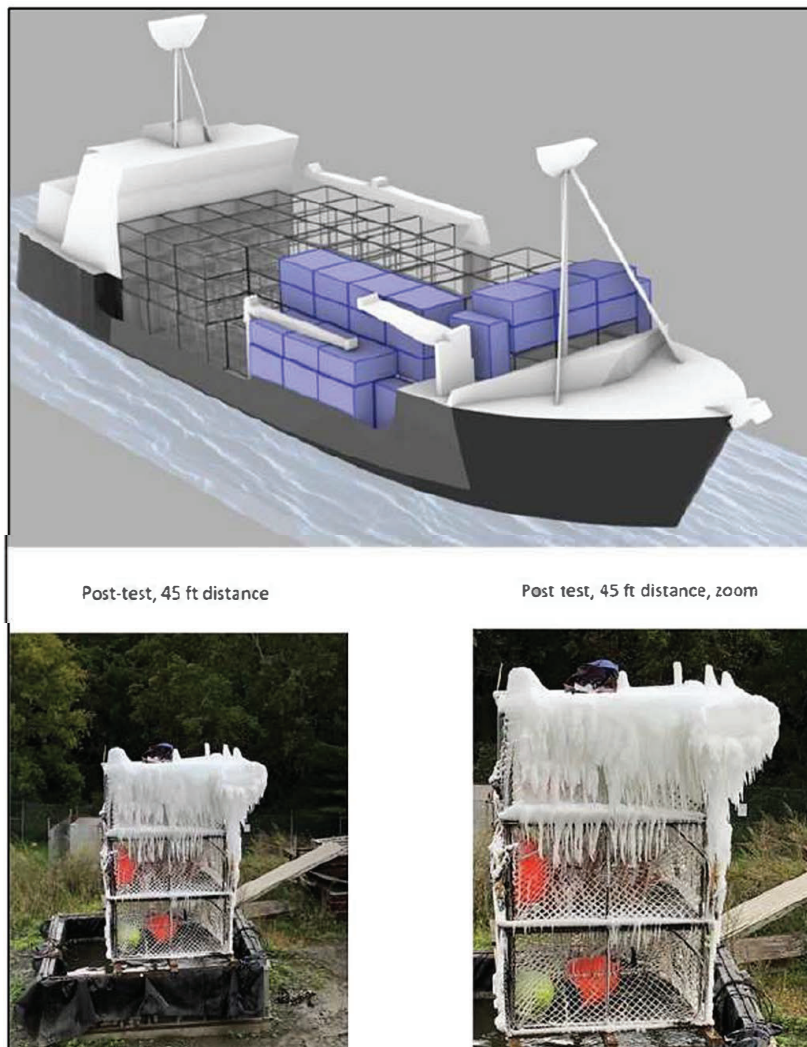
<sup>173</sup> The MSC provided a comprehensive model of the SCANDIES ROSE potential for asymmetrical ice accretion which can be viewed in the upper image of figure 110. Complete details can be found in CG Exhibit 138.

One of the aspects of this series of experiments was to determine the thickness of ice created by a saltwater spray on crab pots on a vessel. The two survivors testified about ice they saw form on the vessel and the crab pot stacks from their vantage point in the wheelhouse of the SCANDIES ROSE. Onboard the vessel, the distance from the wheelhouse to the forward pot stack would have been approximately 65 ft. At the conclusion of one of the tests on the triple pot stack, the stack was moved outside the chamber and placed approximately 45 feet from the camera and the camera would look at the top of the stack from an angle roughly simulating the viewing angle from the SCANDIES ROSE wheelhouse. In figure 110, below you can see the difficulty of accurately determining the thickness of ice when there is no reference point for the frame of the pots. One can also see an example of how the ice formed vertically in a stack of pots in the test chamber, and, in addition to the accretion on the frame, developed overhanging icicles of three-foot length.

Figure 110 – Top, MSC Model<sup>272</sup> of the SCANDIES ROSE which shows distance from the wheelhouse to the forward parts of the vessel and the potential ice load for 24 of the crab pots onboard which would have had the highest exposure to heavy freezing spray, indicated by the purple color. Below left, a triple pot stack when viewed at a distance of 45 feet showing the thickness of ice. Below right, a close up at the same distance showing the type of ice that formed vertically on the mesh and inside the pots. (Source Coast Guard)

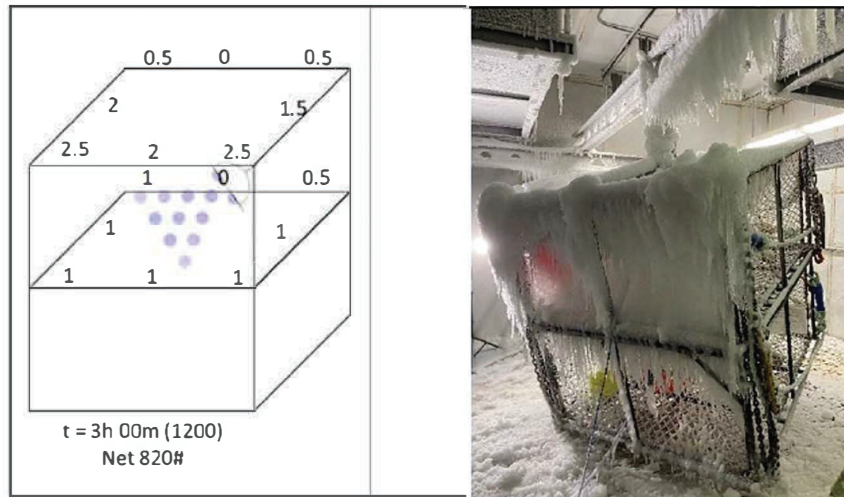
Figure 111 – A double pot stack which was subjected to a side spray of saltwater for a period of three hours, showing a net weight gain of 820 pounds and extensive amount of external ice which included ice on the suspending chains attached to the overhead load cell. In the diagram at the left top, one can see the thickness of ice on top of the pot frame and along the bottom frame as indicated by the associated measurements in inches. (Source Coast Guard)

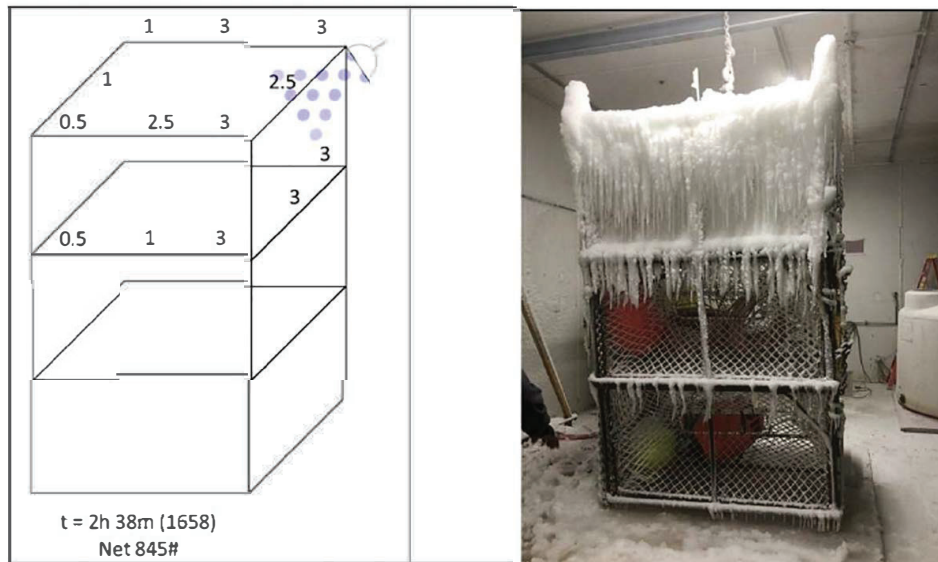
Figure 112 – A triple pot stack which was subjected to a corner spray of saltwater for a period of 2 hours and 38 minutes, showing a net weight gain of 845 pounds and the suspending chains attached to the overhead load cell. In the diagram at the left top, one can see the thickness of ice on top of the pot frame and along the bottom frame as indicated by the associated measurements in inches. (Source Coast Guard)

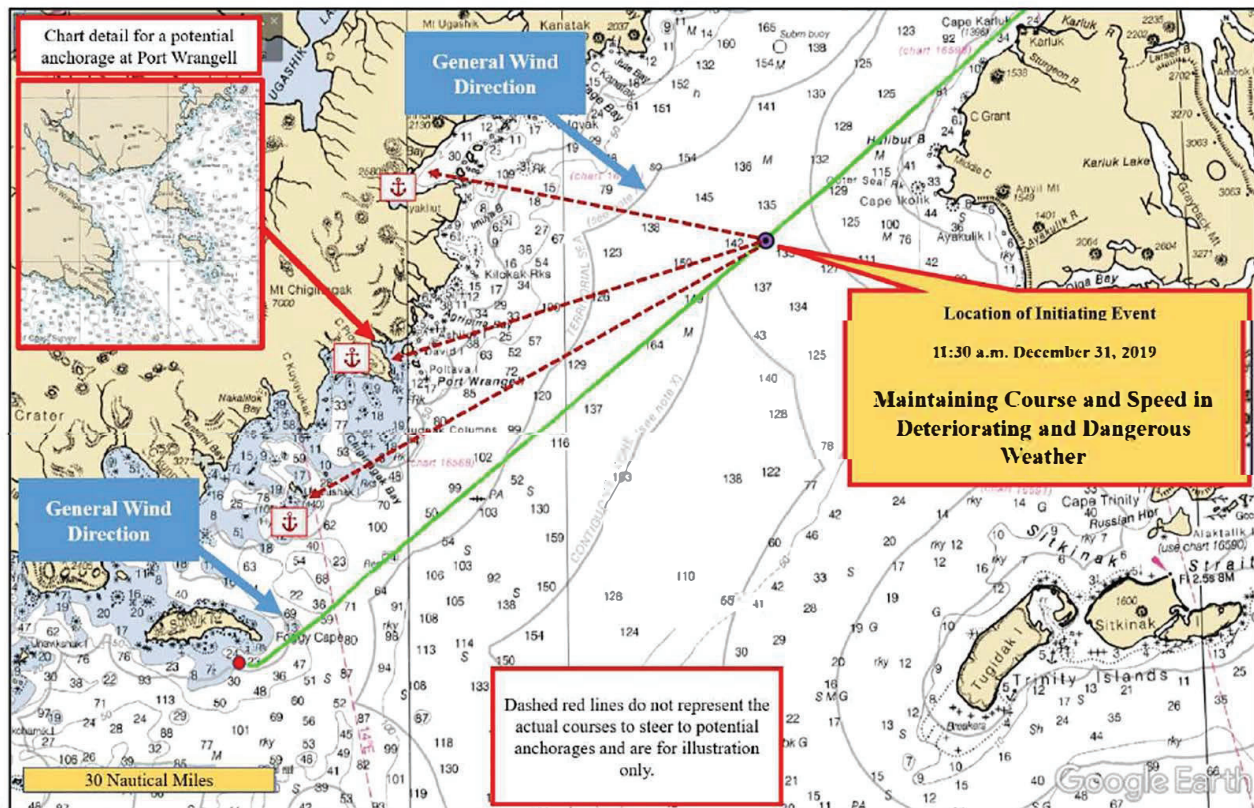
SCANDIES ROSE failed to seek refuge as the freezing spray, which was forecasted, and ice continued to form on the vessel during the morning of December 31, 2019. At approximately 11:30 a.m. the vessel continued on its course and speed to the fishing grounds. All of the actions and decisions made by Captain [REDACTED] that caused the SCANDIES ROSE to continue on the intended voyage as opposed to seeking a safe harbor along the route travelled cannot be precisely determined, as the Captain perished in the accident and he did not communicate his reasoning to the surviving crew. Based on the available evidence and analysis, the causal factors were:

Figure 113 – Location of the “Initiating Event” for the accident, the decision point where the Captain of the SCANDIES ROSE maintained course and speed towards False Pass, despite the dangerous anticipated weather, phone call to the AMATULLI, ice having formed on the vessel and pots and daylight to observe his vessel. The red dashed lines indicate potential points where the SCANDIES ROSE might have anchored due to the weather and ice formation which would have afforded the vessel protection from the ice formation. (Source Coast Guard)

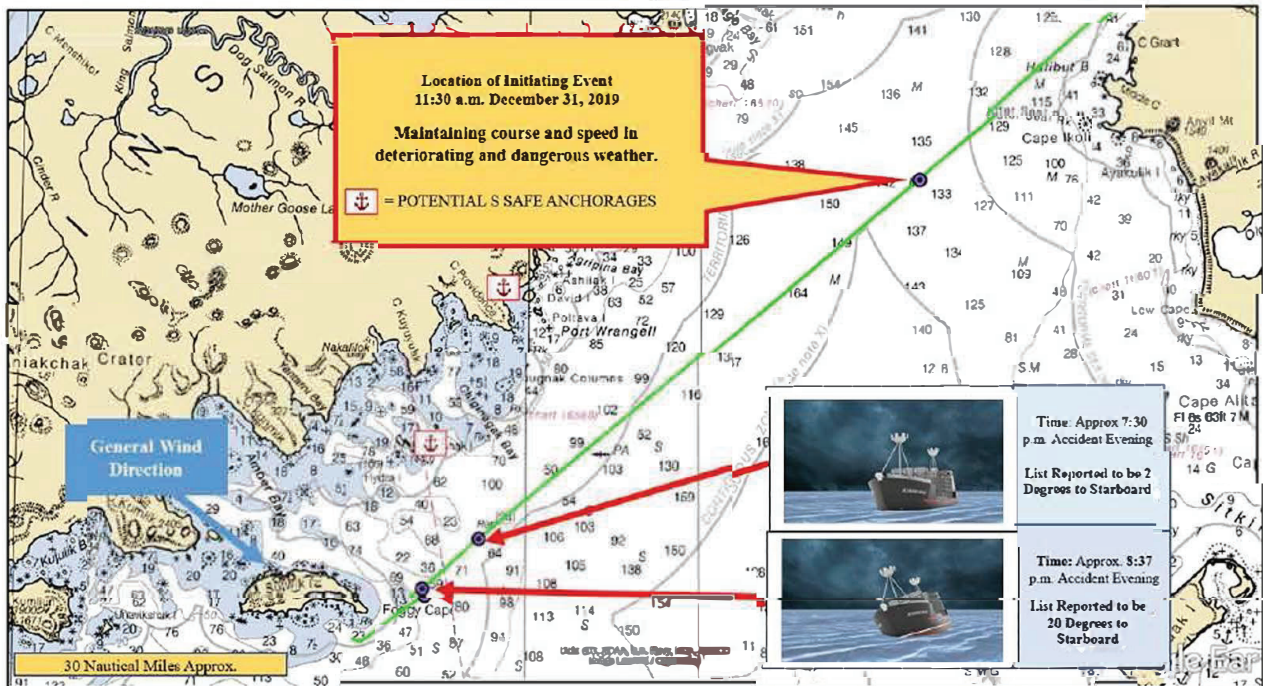
Figure 114 – Track of the SCANDIES ROSE on the accident evening with positions for reported two-degree list reported at approximately 7 00 p.m. and then the list of approximately 20 degrees reported at approximately 8 37 p.m. on the accident evening. Insets show the RHINO computer model visualization of the listing vessel superimposed for illustration purposes. (Source Coast Guard)

6.1.4.1. The Captain and crew failed to acknowledge and address that the change in list which went from “a couple of degrees” to the next reported measurement of list of 20 degrees to starboard was an emergency situation.

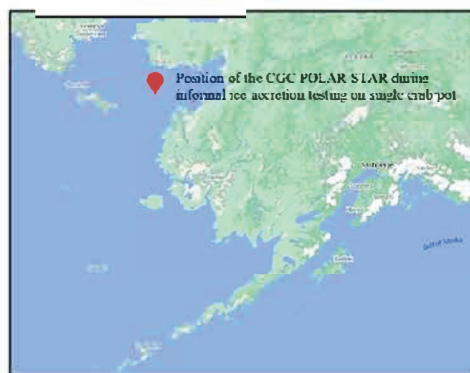
Figure 117 – The symbol on the map indicates the position of the Coast Guard's POLAR STAR when they were conducting the onboard single crab trap icing informal test. The test used freshwater over a 72-hour period with ambient air temperature at approximately 15° Fahrenheit. (Source Coast Guard)

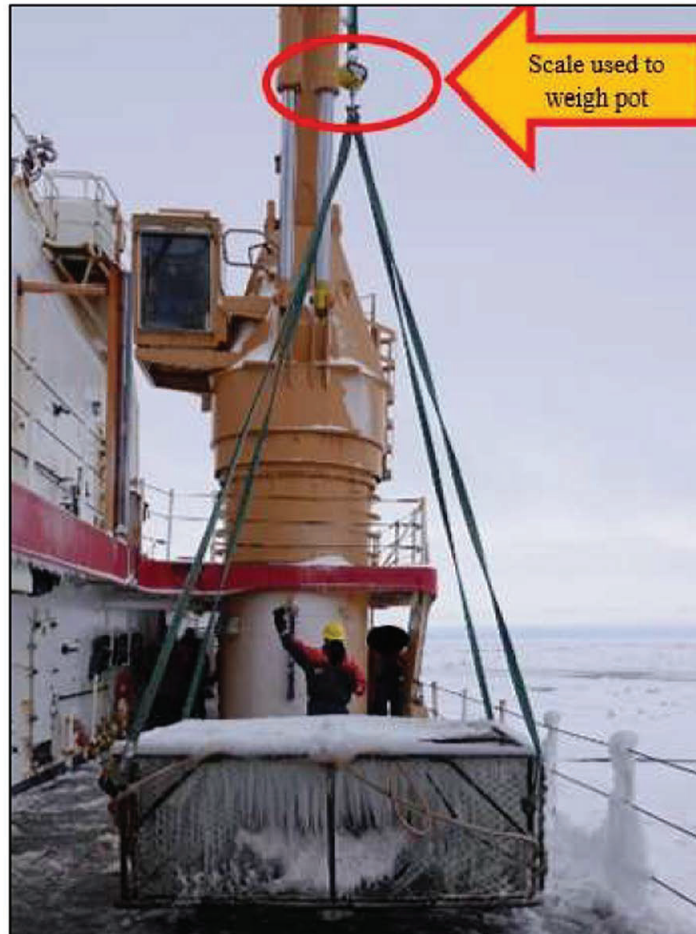
ship's crane with a load cell in the lifting rig capable of weighing an object up to 3,000 pounds. The dry weight of the crab pot and gear at the start of the experiment was just under 1,000 pounds. At the conclusion of the 72-hour period, the pot encrusted with ice exceeded the capacity of the 3,000 pound scale. This non-scientific study was discussed in the MBI Hearing and would lead to a formal scientific study conducted by the RDC.

*Figure 118 – The crab pot that was subjected to the freezing freshwater spray is weighed onboard the POLAR STAR at the conclusion of a 72-hour period. The yellow arrow points to the scale mounted in the lifting apparatus. (Source Coast Guard)*

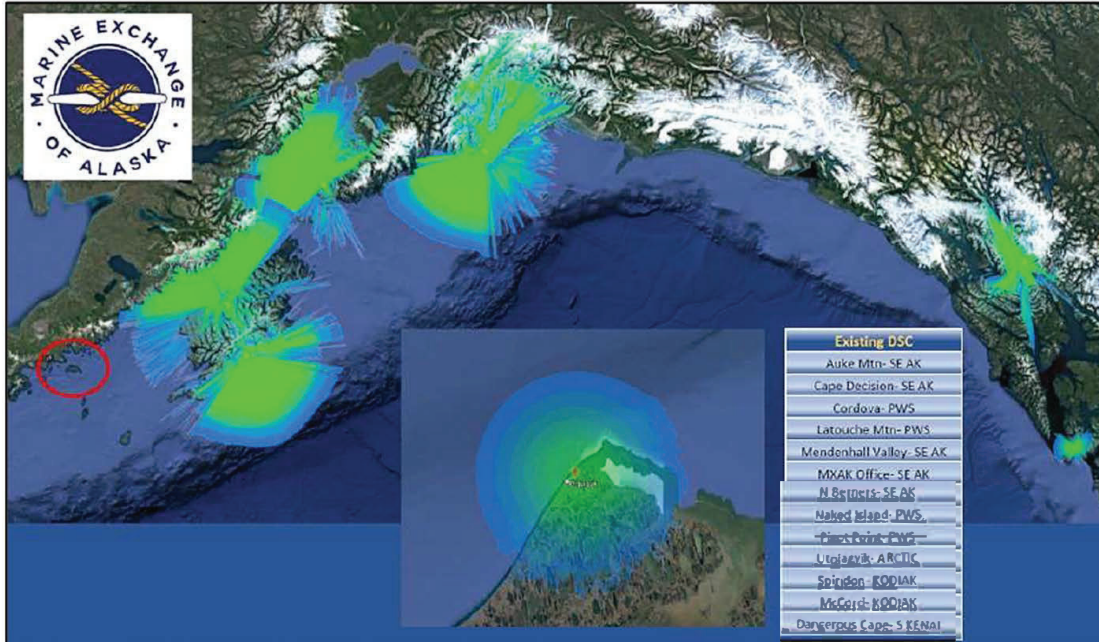
Figure 119 – Image of existing DSC coverage in Alaska in mid-summer 2021. Sutwik Island is circled in red and was not within a Marine Exchange DSC reception area at the time of the accident. (Source Marine Exchange of Alaska, with Coast Guard mark up)

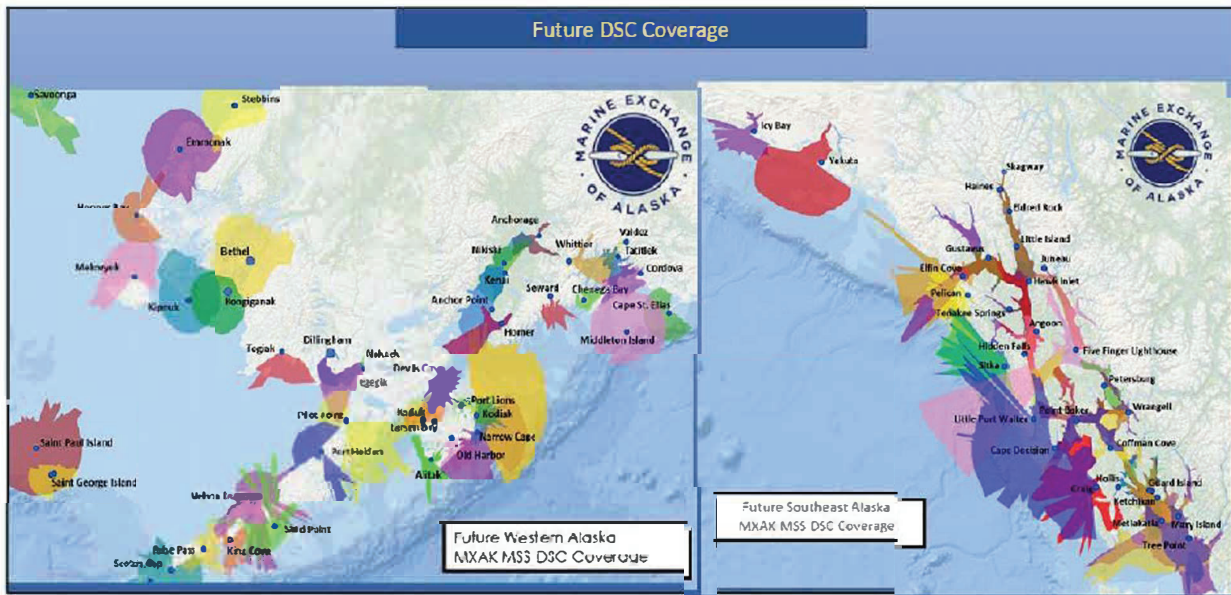
Figure 120 – Image of 1 planned VHF DSC coverage in Alaska based on Marine Exchange of Alaska’s plan to install DSC receivers on their existing antenna sites. If all DSC receivers are installed as intended, the area in which the SCANDIES ROSE marine accident occurred will have DSC coverage. (Source Marine Exchange of Alaska)

8.1.10. Recommend that the Commandant of the Coast Guard promote the use of a properly installed and configured Digital Selective Calling feature on marine VHF radios throughout
