MIR-22/26

# Capsizing of Liftboat *SEACOR Power*

Port Fourchon, Louisiana

April 13, 2021

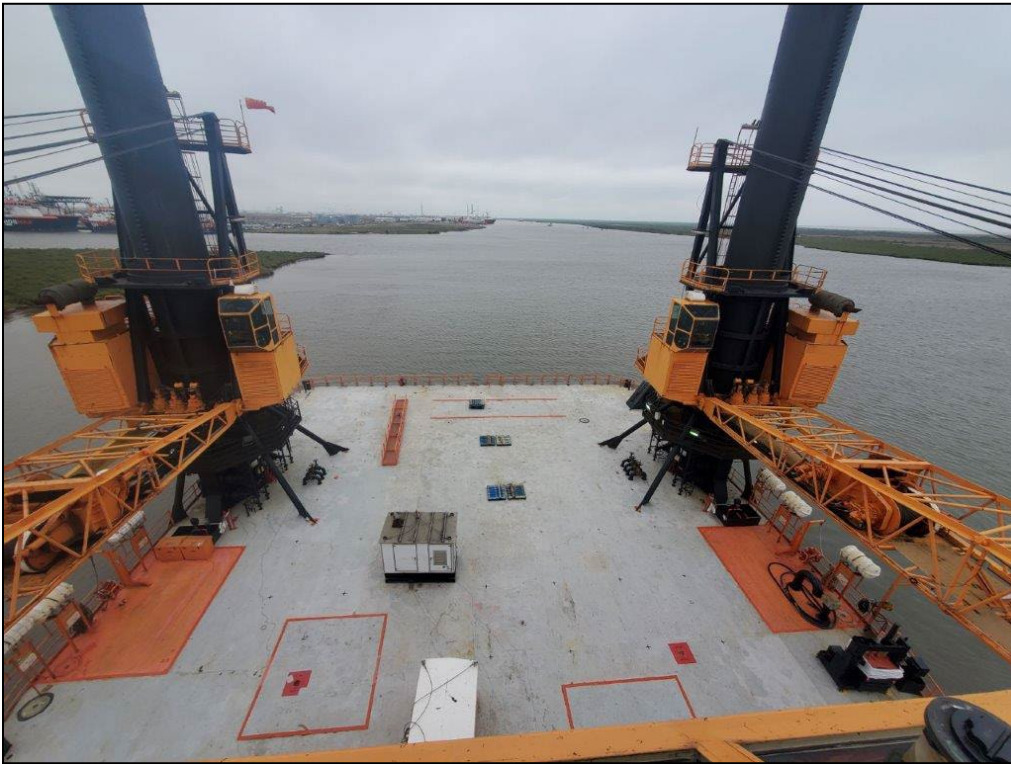
The forward main deck of the vessel provided a large, open area for working and cargo stowage (see Figure 11). The deck in this area was coated with non-skid

paint; investigators examined the deck on the vessel following salvage and noted no damage to the non-skid coating other than minor scrapes and gouges.

**Figure 11.** *SEACOR Power* main deck cargo/working area looking forward. (Source: SEACOR Marine)

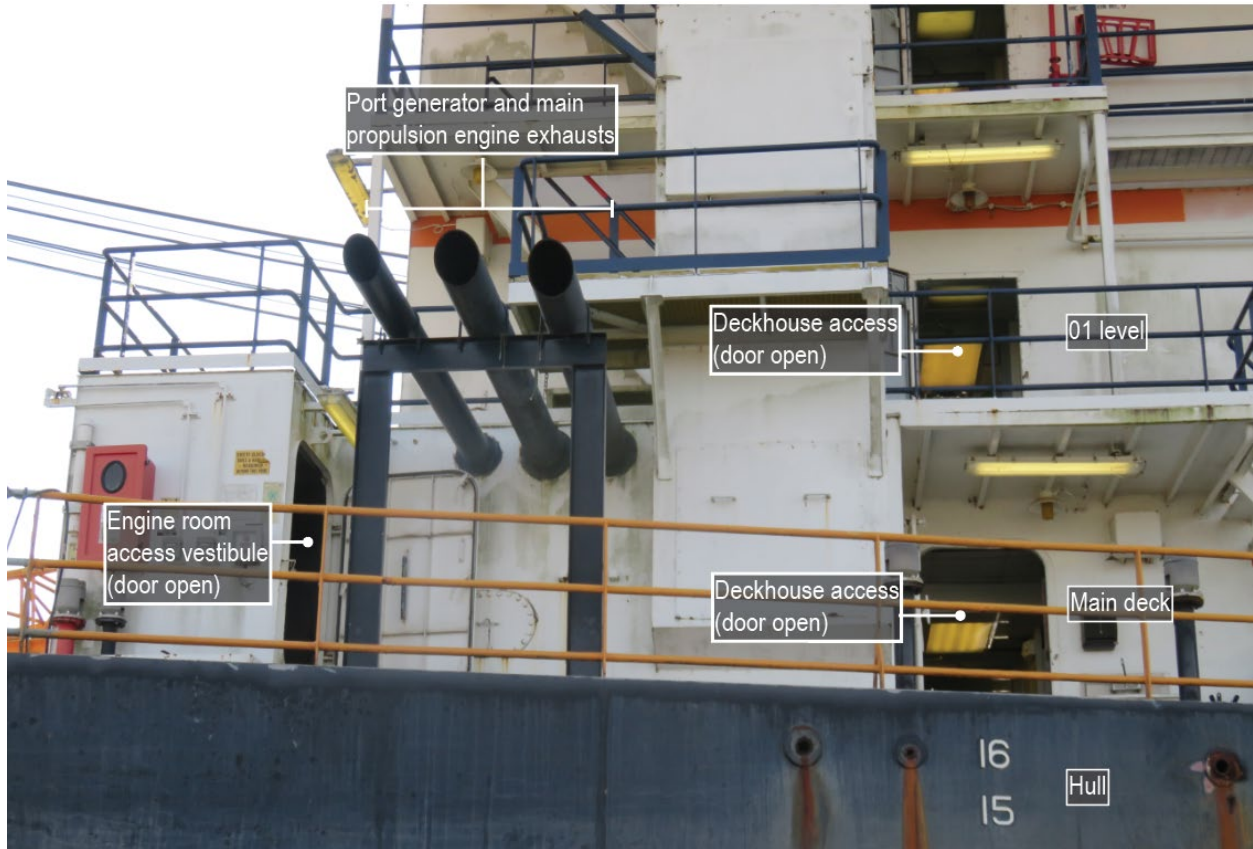
The deckhouse, located aft on the vessel, included a galley and a dining area on the main deck. Access to the main deck exterior was via watertight doors (see Figure 12). The three levels above the main deck, numbered 01 to 03, comprised berthing and lounge spaces for crew and offshore workers. The wheelhouse was above the 03 level. All deckhouse levels and the wheelhouse were also accessible by external catwalks and stairways on the port and starboard sides of the vessel. Entrances to the deckhouse levels from the catwalks were via vestibules with external [weathertight](#) doors and internal non-weathertight doors.

**Figure 12.** Portside deckhouse and engine room accesses on similar vessel *SEACOR Legacy*.

The engine rooms were accessed via companionways leading down from vestibules on the port and starboard side of the main deck. A watertight door on each of the engine room access vestibules opened to the exterior main deck (see Figure 12). Within the hull, watertight doors on the inboard side of the engine rooms allowed access to the centerline equipment room and the opposite engine room. There was no interior access to the engine rooms or equipment room from the deckhouse above.

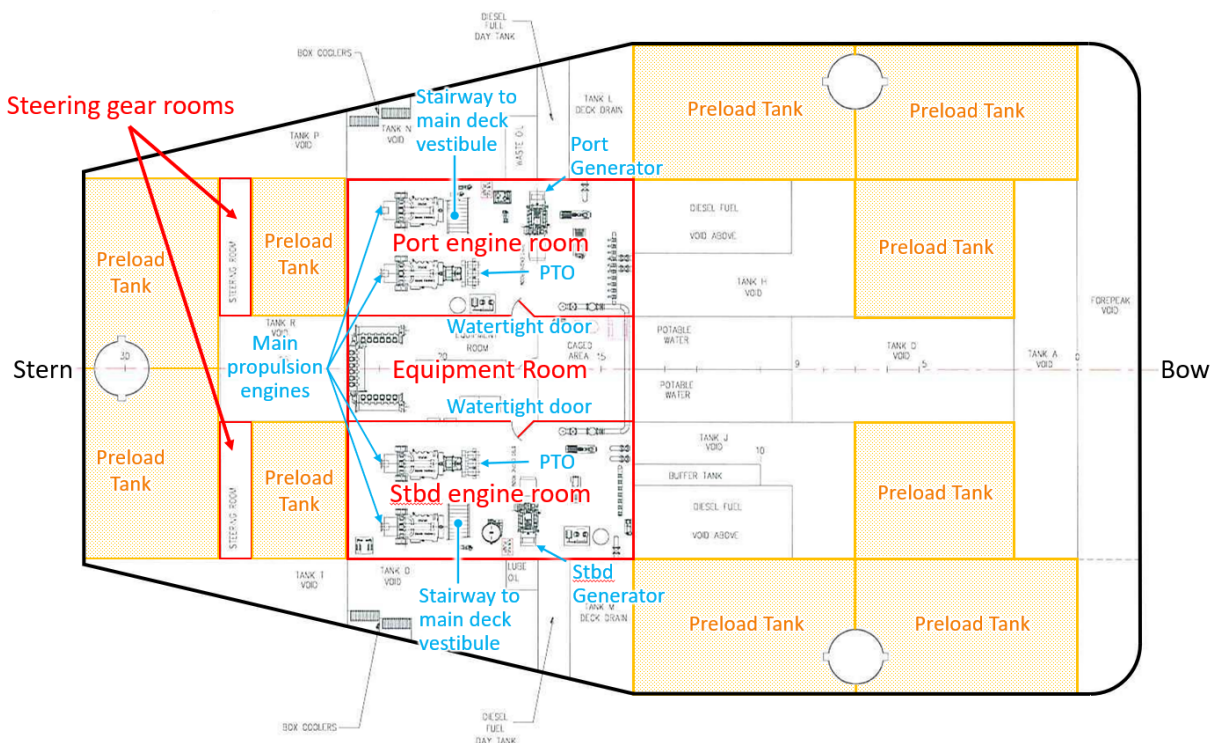
The spaces within the hull of the *SEACOR Power* comprised port and starboard engine rooms with an equipment room in between, port and starboard steering gear rooms, fuel and potable water tanks, preload tanks (tanks filled with water during an initial vessel jack-up in a new location to test the seafloor condition), and various other tanks and voids (see Figure 13). The engineer's watch station was located in the equipment room.

**Figure 13.** *SEACOR Power* hull compartments, tanks, and voids. (Background source: SEACOR Marine)

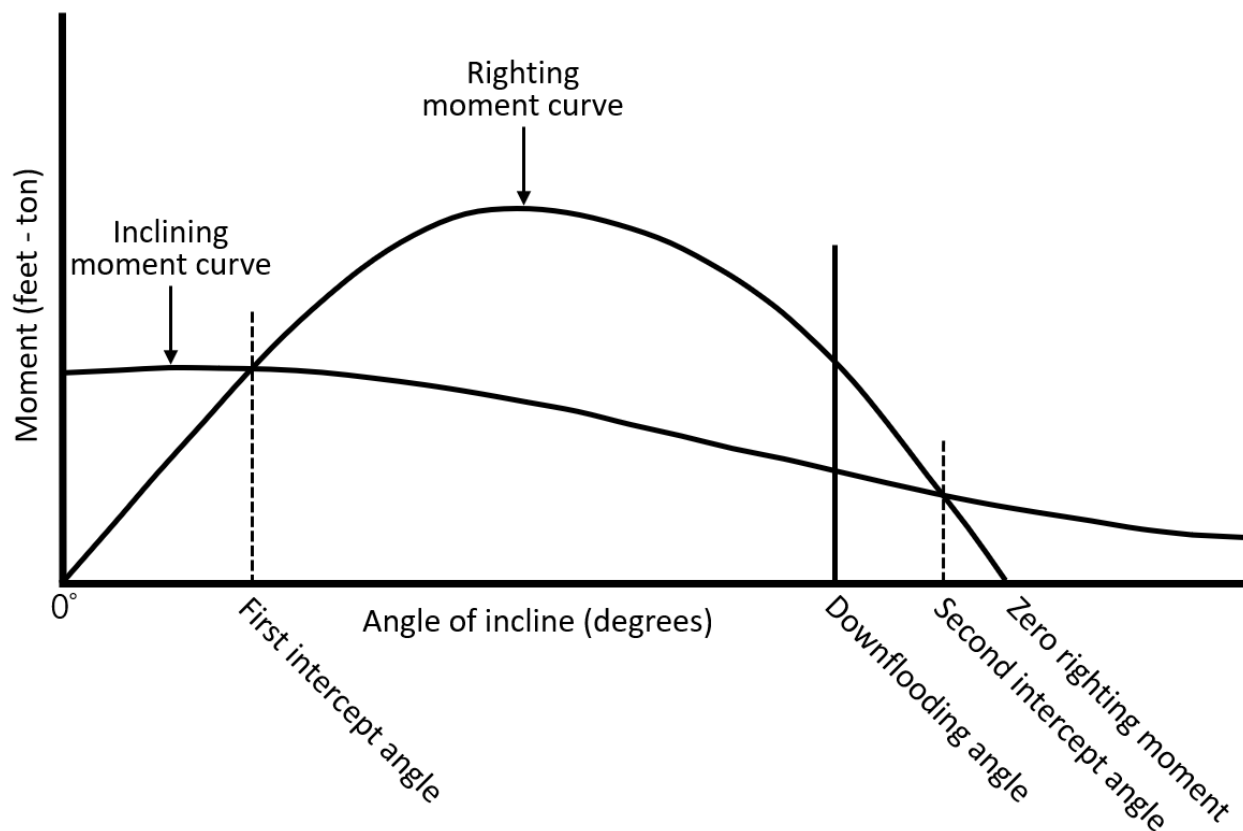
Liftboat intact stability requirements are expressed as the relationship between a vessel's righting moment (the vessel's tendency to return to equilibrium) and wind inclining moment (the sum of a given wind's forces acting on a vessel) when the vessel is inclined from upright (0°) to the angle of downflooding or the angle that the vessel capsizes. Righting moments and wind inclining moments can be plotted as curves on a graph of intact stability (see Figure 21). See [Appendix C: Load Lines and Principles of Stability](#) for additional information.

**Figure 21.** Righting and inclining moment curves for intact stability. The second intercept angle is the angle at which the vessel will capsize when subjected to a given wind. (Adapted from Graph 174.045, 46 *CFR* 174)

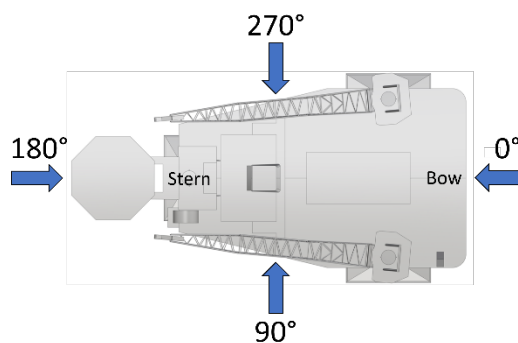
The Coast Guard conducted two sets of analyses for each condition that it evaluated. In its first set of analyses, the model was not permitted to twist (or yaw) about its vertical axis as it was inclined, which was in keeping with the methodology used at the time of the *SEACOR Power's* construction in 2002. With this “fixed-axis” constraint, the model had a tendency to lose stability and the righting moment curve was truncated as it was inclined towards axes just off the bow or stern, a phenomenon known as “fading stability.” The MSC noted that this phenomenon was unrealistic because an actual vessel will yaw as it is inclined, rotating to the position where righting energy is weakest.

**Figure 22.** Diagram of a liftboat showing relative wind directions. (Background source: MSC)
